# **Mallee Catchment Management Authority**

## **Report for Margooya Lagoon Monitoring Program**

October 2008

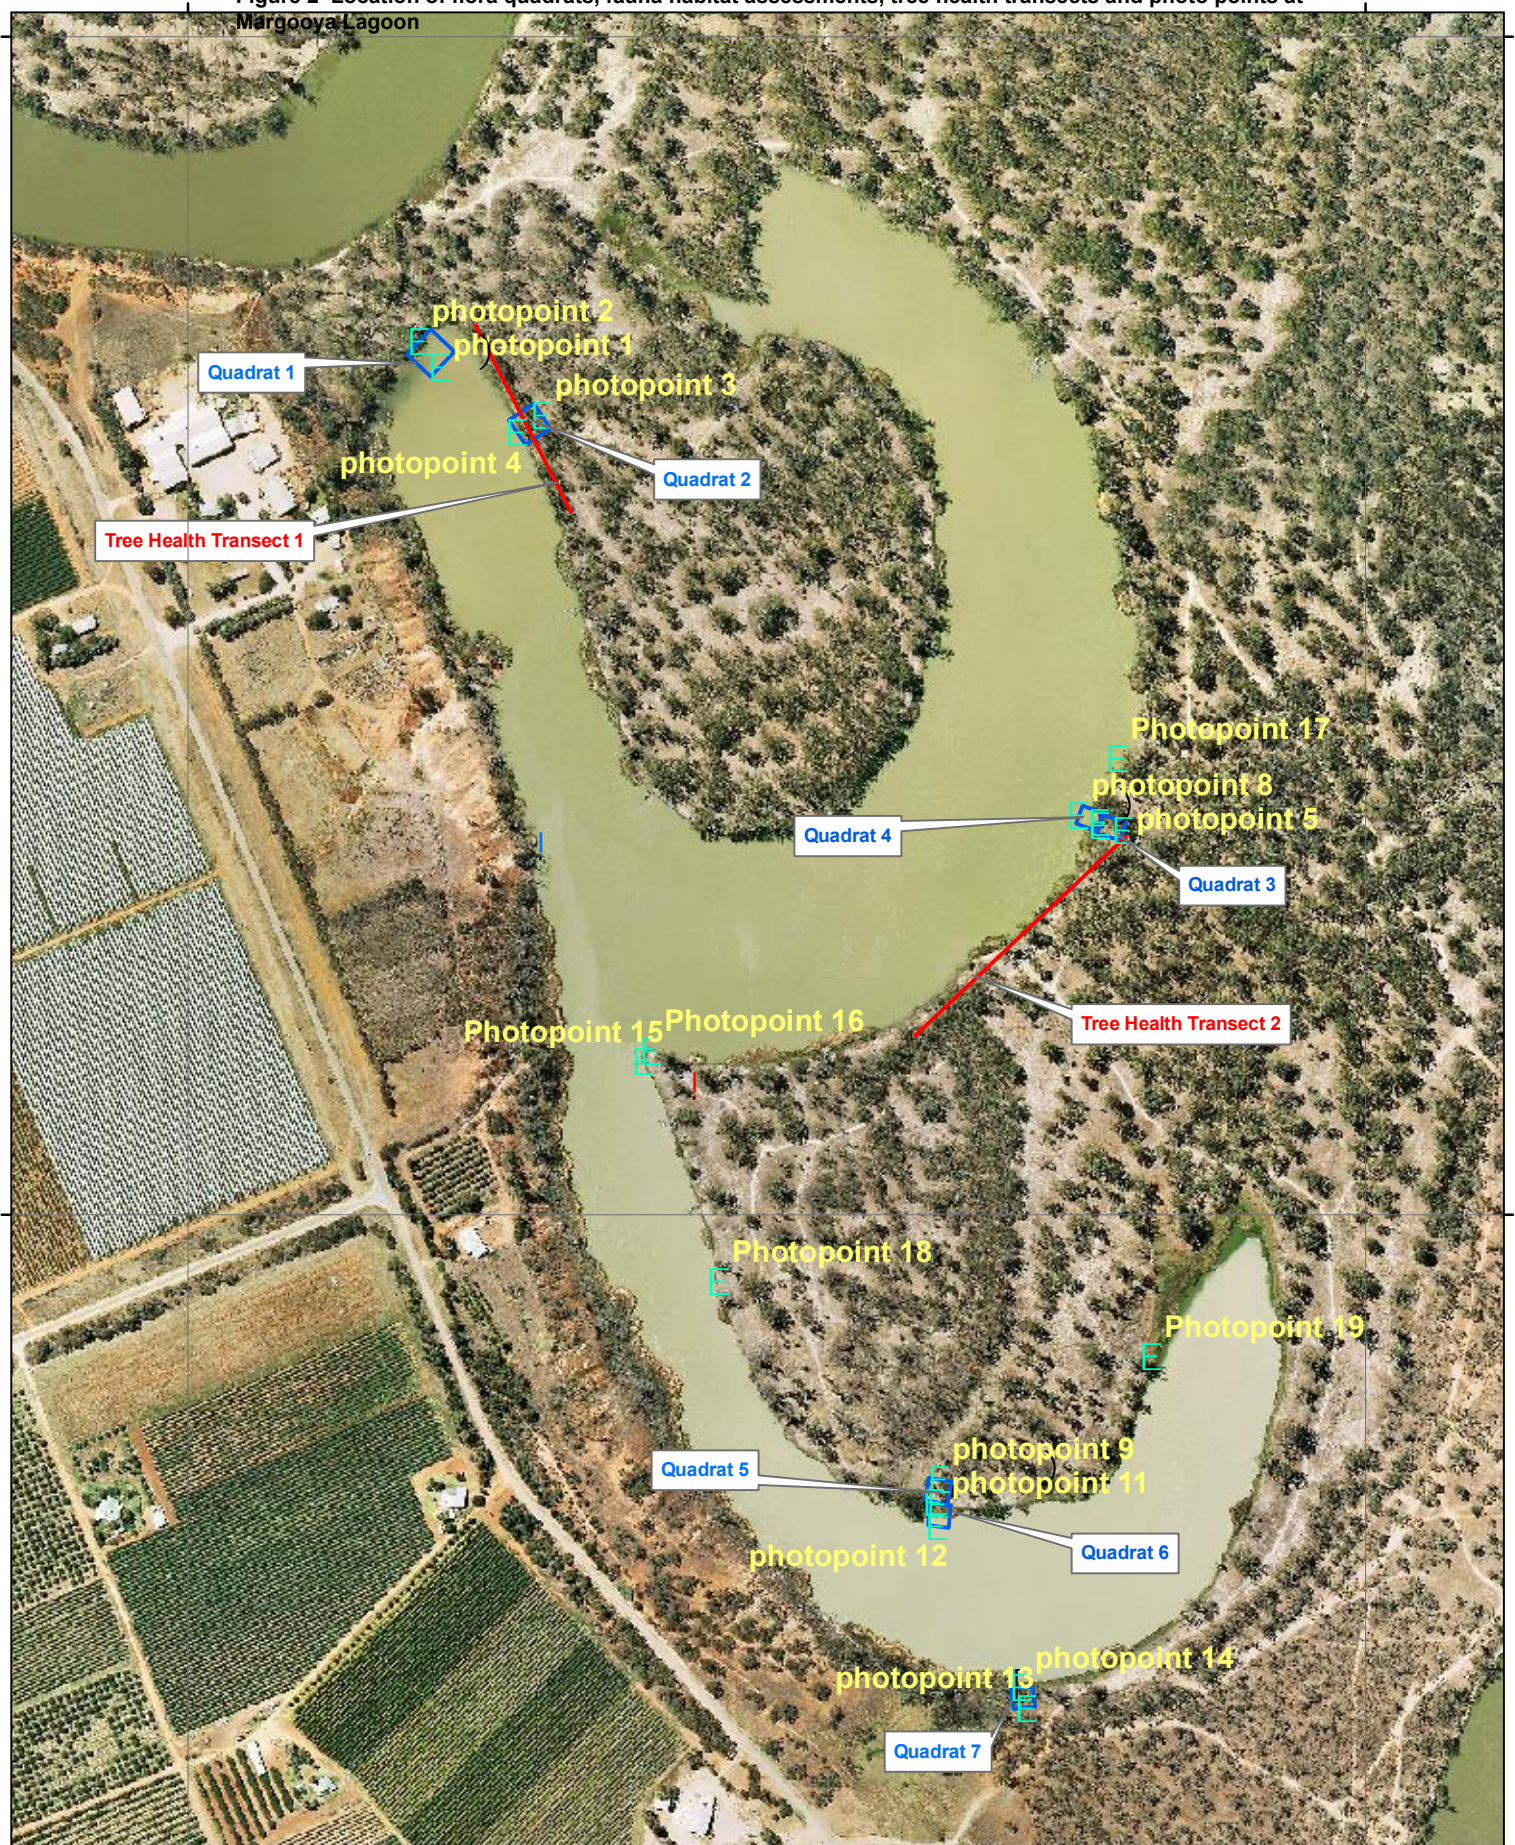
Figure 2 Location of flora quadrats, fauna habitat assessments, tree health transects and photo points at Margooya Lagoon

Photo points were established at the locations provided in Table 2 and Figure 2. The Mallee CMA will need to permanently mark these sites, if they are to be used as ongoing monitoring points. Photo points were established at either end of each quadrat and at other areas of interest around Margooya Lagoon. Photo points 15 to 19 are not in association with a vegetation monitoring quadrat and were selected as broad observational photo points to assess changes to Margooya Lagoon over time and depending on the water regime currently operating (e.g. wet or dry). Refer to Appendix G for photos of these sites.

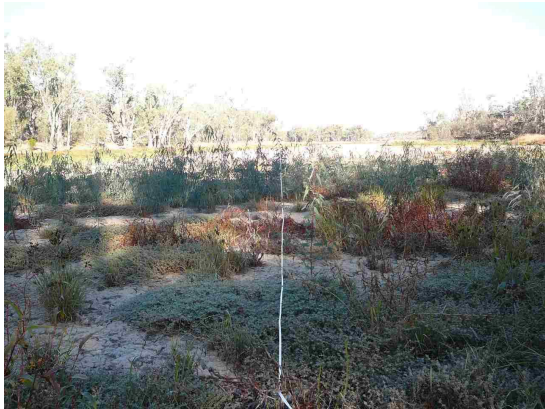
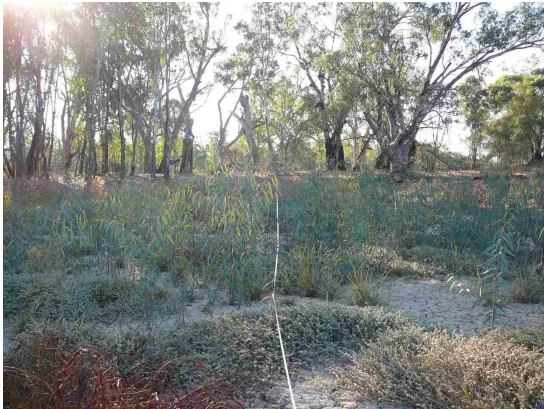
Start: Easting 669196    Northing 6166741	Quadrat 1 was located at the edge of the wetland bed in the northern section of the lagoon, which is closest to the Murray River.
Finish: Easting 669214    Northing 6166719	
<p><b>Vegetation:</b> consists of dense cover of prostrate herbs generally &lt;0.5m high and tufted graminoids to 1m tall. Dense regeneration of <i>Eucalyptus camaldulensis</i> (River Red-gum) up to 2m high. Within an area of 10m x 5m patch there are approximately 28 individuals of juvenile River Red-gum to 2 m high. <b>Soil:</b> grey cracking clay.</p>

<b>Quadrat 1 view looking across wetland (Photo point 1)</b>	<b>Quadrat 1 view looking towards bank (Photo point 2)</b>
Ecological Vegetation Class	Bare ground according to EVC mapping, could be considered as Tall Marsh (EVC 821)
<b>Dominant trees</b>	None recorded
<b>Canopy trees</b>	None recorded
<b>Small trees</b>	None recorded

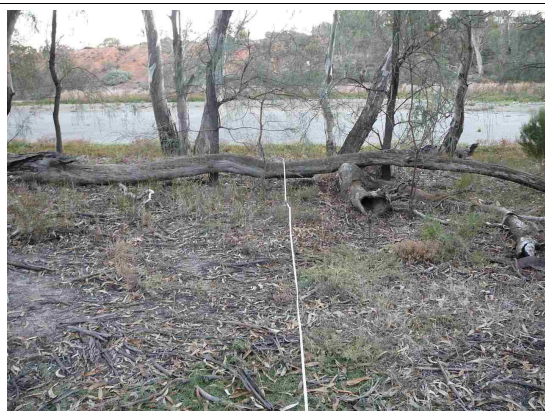
**Quadrat 2 view looking toward wetland (photo point 3)**

**Vegetation:** Open woodland of *Eucalyptus camaldulensis* (River Red-gum) to 20m tall over a small tree layer of *Acacia stenophylla* (Eumong) to 6m tall. Ground layer is sparse but includes medium tufted graminoids < 0.5m tall and small to medium herbs < 0.3m tall.

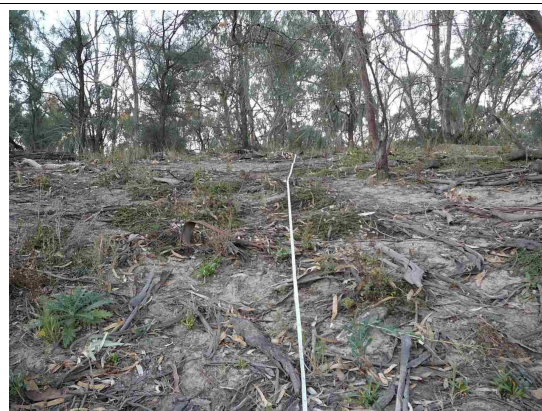
**Quadrat 2 view looking toward woodland (photo point 4)**

<b>Ecological Vegetation Class</b>	Intermittent Swampy Woodland (EVC 813)
<b>Dominant trees</b>	<b>Cover and height</b>
<b>Canopy trees</b>	
<i>Eucalyptus camaldulensis</i> (River Red-gum)	5-25% cover, up to 20m tall
<b>Small trees</b>	
<i>Acacia stenophylla</i> (Eumong)	5-25% cover, up to 6m tall
<b>Dominant shrubs</b>	<b>Cover and height</b>
<i>Glycyrrhiza acanthocarpa</i> (Southern Liquorice)	<5%, up to 0.3m tall
<i>Rhagodia spinescens</i> (Hedge Saltbush)	+, up to 0.3m tall
<b>Dominant ground species</b>	<b>Cover and height</b>
<i>Cyperus gymnocaulos</i> (Spiny Flat-sedge)	5-25% cover, up to 0.5m tall
<i>Atriplex semibaccata</i> (Berry Saltbush)	5-25% cover, up to 0.5m tall
<i>Vittadinia</i> spp. ( <i>V. cuneata</i> ; Fuzzy New Holland Daisy and <i>V. dissecta</i> ; Dissected New Holland Daisy)	<5% cover, up to 0.1m tall
<b>Weed cover</b>	5-25%
<b>Dominant weed species</b>	<i>Cirsium vulgare</i> (Scotch Thistle) <i>Phyla canescens</i> (Fog-fruit) <i>Bromus rubens</i> (Red Brome)

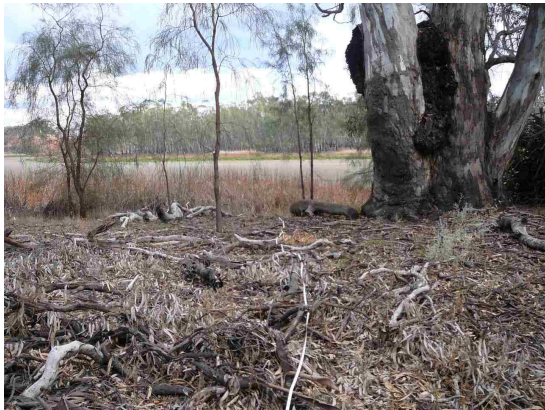
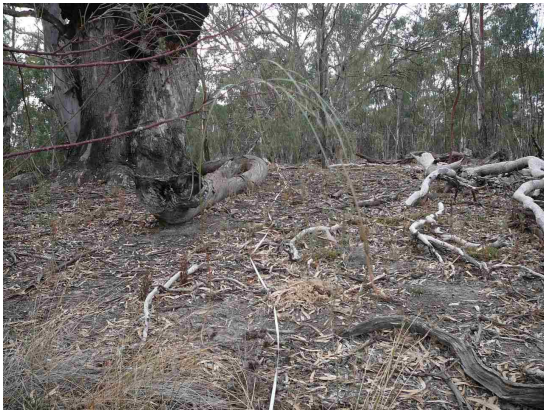
Start: Easting 669774    Northing 6166330 Finish: Easting 669794    Northing 6166326		Quadrat 3 is located within River Red-gum woodland on the eastern side of the Lagoon
<b>Vegetation:</b> Open woodland of <i>Eucalyptus camaldulensis</i> (River Red-gum), with an understorey tree layer of <i>Acacia stenophylla</i> (Eumong). Ground layer is sparse and supports medium tufted graminoids and small to medium herbs. Occasional chenopods e.g. <i>Rhagodia spinescens</i> (Hedge Saltbush).

<b>Quadrat view looking toward wetland (photo point 5)</b>		<b>Quadrat view looking toward woodland (photo point 6)</b>
<b>Ecological Vegetation Class</b>		Intermittent Swampy Woodland (EVC 813)
<b>Dominant trees</b>		<b>Cover and height</b>
<b>Canopy trees</b>		
<i>Eucalyptus camaldulensis</i> (River Red-gum)		5-25% cover, up to 20m tall
<b>Small trees</b>		
<i>Acacia stenophylla</i> (Eumong)		5-25% cover, up to 10m tall

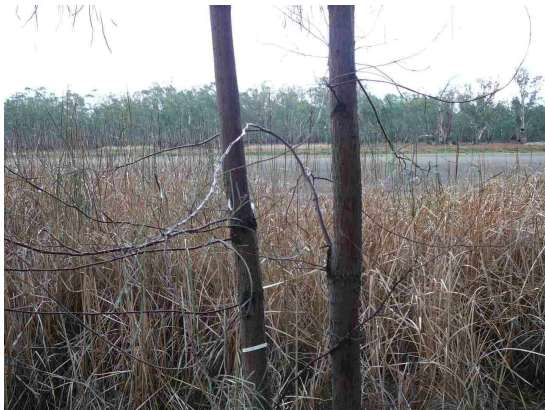
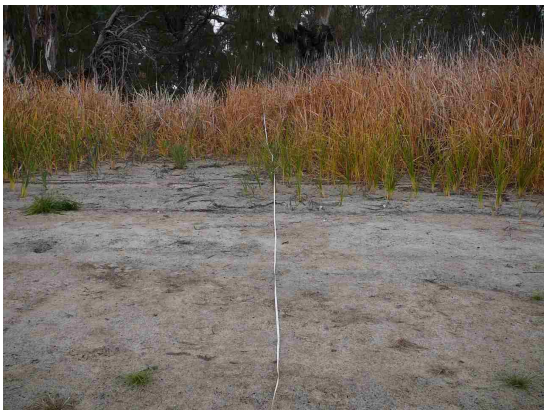
Start: Easting 669756    Northing 6166339	Quadrat 4 is located adjacent to quadrat 3 within the wetland bed and edge of bank.
Finish: Easting 669774    Northing 6166333	
Vegetation: Edges of wetland bed are dominated by tall emergent graminoids (rushes and sedges) such as <i>Typha orientalis</i> (Broad-leaf Cumbungi). Some <i>Eucalyptus camaldulensis</i> (River Red-gum) regeneration in bed, approximately 16 individuals in a 10 m x 10 m area.

<b>Quadrat 4 view looking across wetland (photo point 7)</b>	<b>Quadrat 4 view looking toward woodland (photo point 8)</b>
<b>Ecological Vegetation Class</b>	Bare ground according to EVC mapping, but could be considered as Tall Marsh (EVC 821)
<b>Dominant trees</b>	<b>Cover and height</b>
<b>Canopy trees</b>	None recorded
<i>Eucalyptus camaldulensis</i> (River Red-gum), overhanging	<5% cover, overhanging
<b>Small trees</b>	
<i>Acacia stenophylla</i> (Eumong), overhanging	<5% cover, up to 10m tall

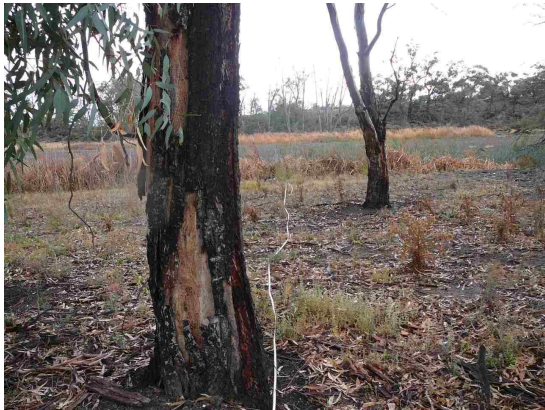
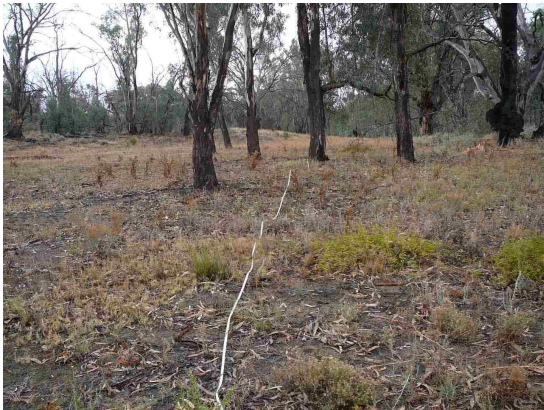
Start: Easting 669634    Northing 6165755	Quadrat 5 is located at the southern end of the Lagoon within River Red-gum woodland.
Finish: Easting 669638    Northing 6165775	
<b>Vegetation:</b> Open woodland of <i>Eucalyptus camaldulensis</i> (River Red-gum) to 20m tall. Eucalypts young and tall, with DBH generally < 50 cm. Shrub layer is very sparse. Ground layer dominated by small to medium herbs such as <i>Senecio quadridentatus</i> (Cotton Fireweed) and occasional medium tufted graminoids.

<b>Quadrat 5 view looking toward wetland (photo point 9)</b>	<b>Quadrat 5 view looking across woodland (photo point 10)</b>
<b>Ecological Vegetation Class</b>	Intermittent Swampy Woodland (EVC 813)
<b>Dominant trees</b>	<b>Cover and height</b>
<b>Canopy trees</b>	
<i>Eucalyptus camaldulensis</i> (River Red-gum)	5-25% cover, up to 20m tall
<b>Small trees</b>	
<i>Acacia stenophylla</i> (Eumong)	+, up to 8m tall

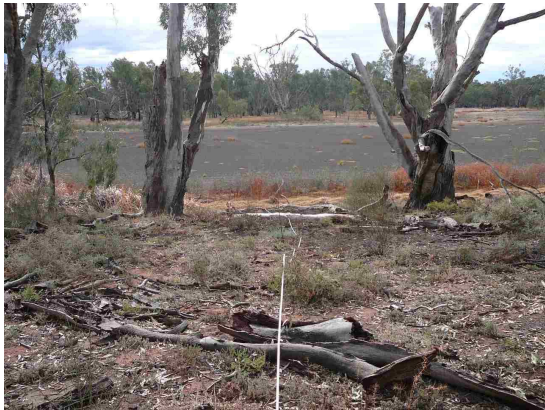
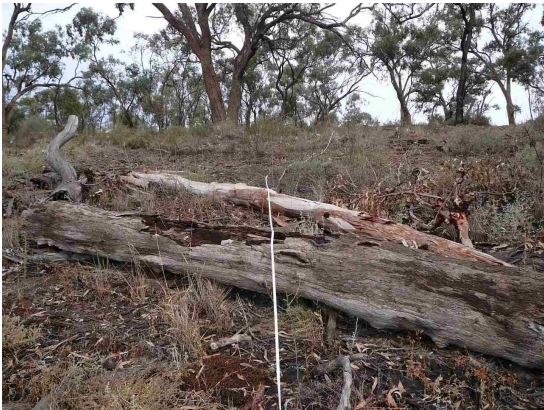
<b>Quadrat 7 view looking toward wetland (photo point 13)</b>		<b>Quadrat 7 view looking across woodland (photo point 14)</b>
<b>Ecological Vegetation Class</b>		Intermittent Swampy Woodland (EVC 813) but perhaps would be better mapped as Riverine Chenopod Woodland (EVC 103)

<b>Vegetation condition</b>		Fair to good as almost weed free, but trees are mostly dead

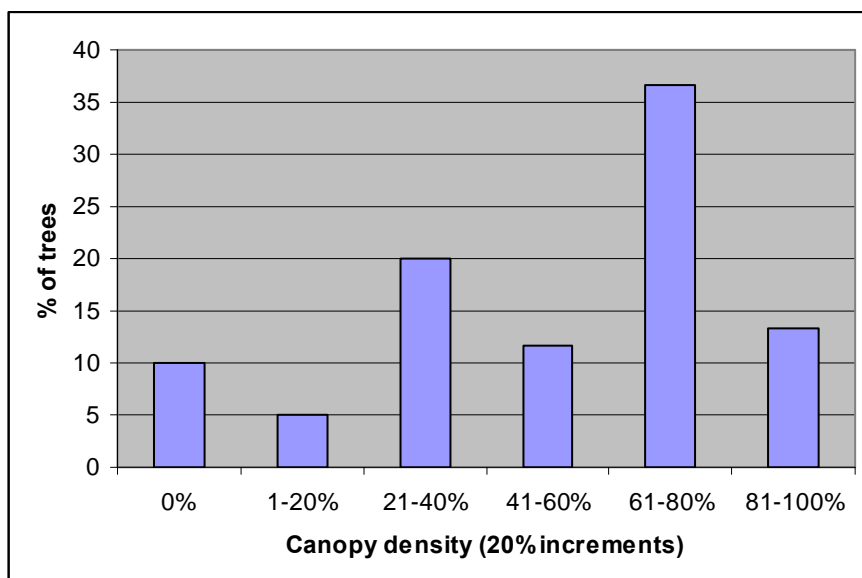
Using the broad scale of canopy cover described by Wallace et al. 2007, most trees scored a 4 out of 5 for canopy cover (26-75% cover) (Figure 6). This result is somewhat misleading as trees that have a canopy cover of 26% are treated the same as trees that have up to 75% canopy cover. Therefore, it is important to also consider the data for canopy cover collected at 20% increments. This data shows that

**Figure 6 Canopy cover of trees surveyed at Margooya Lagoon using 20% increments**

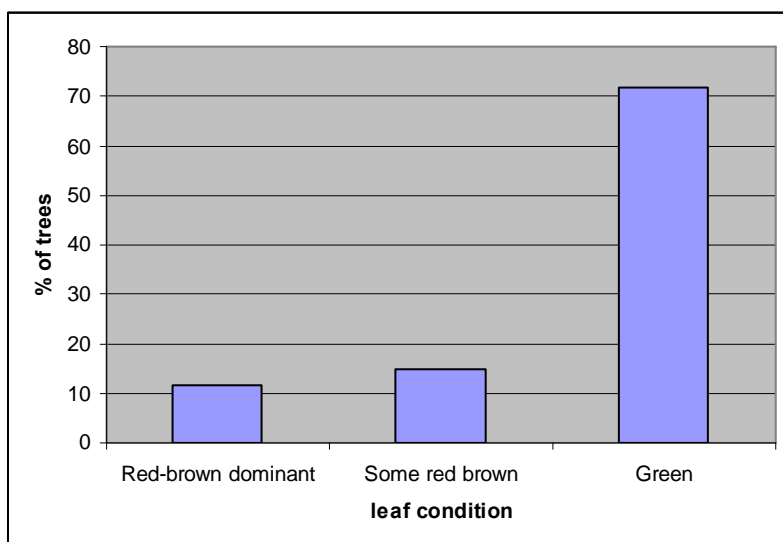
The majority of trees had green leaves and did not show signs of red-brown leaves (one of the symptomatic signs of dieback) (Figure 8).

**Figure 8 Leaf condition of trees surveyed at Margooya Lagoon**

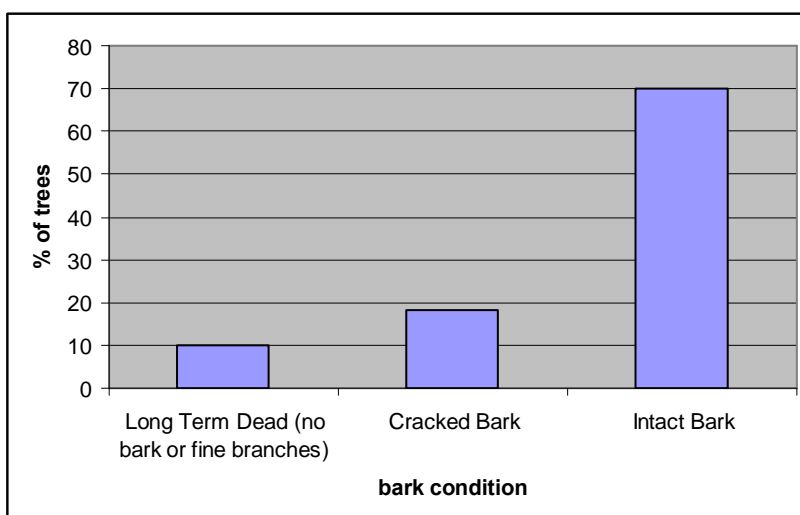
The majority of trees had intact bark (70%) (Figure 9). Trees that were near dead or dead had cracked bark (28%).

**Figure 9 Bark condition of trees surveyed at Margooya lagoon**

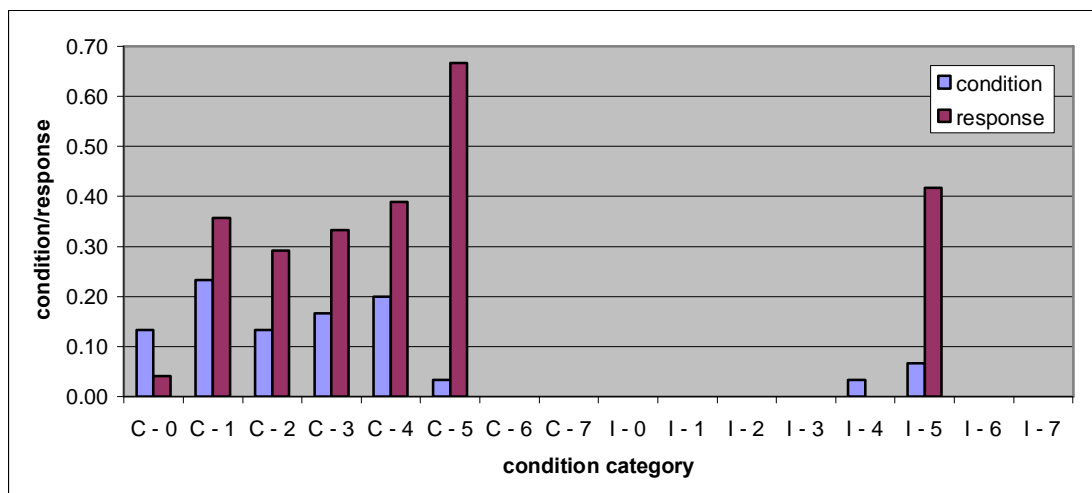
**Figure 11 Red gum condition and trajectory at Transect 1, Margooya Lagoon, Robinvale**

Blue bars are frequency of trees in each condition class (0-7, crown cover plus density score). Purple bars are mean response for each condition class (sum of three positive and three negative response variables scored as 0, scarce or absent; 1 present; 2 dominant). C = cracked bark, I = intact bark.

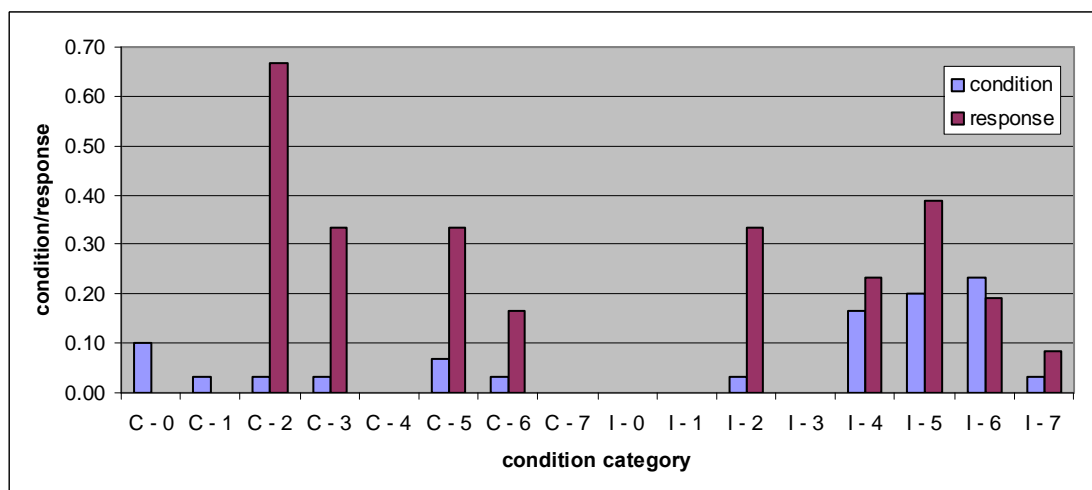
**Figure 12 Red gum condition and trajectory at Transect 2, Margooya Lagoon, Robinvale**

Blue bars are frequency of trees in each condition class (0-7, crown cover plus density score). Purple bars are mean response for each condition class (sum of three positive and three negative response variables scored as 0, scarce or absent; 1 present; 2 dominant). C = cracked bark, I = intact bark.

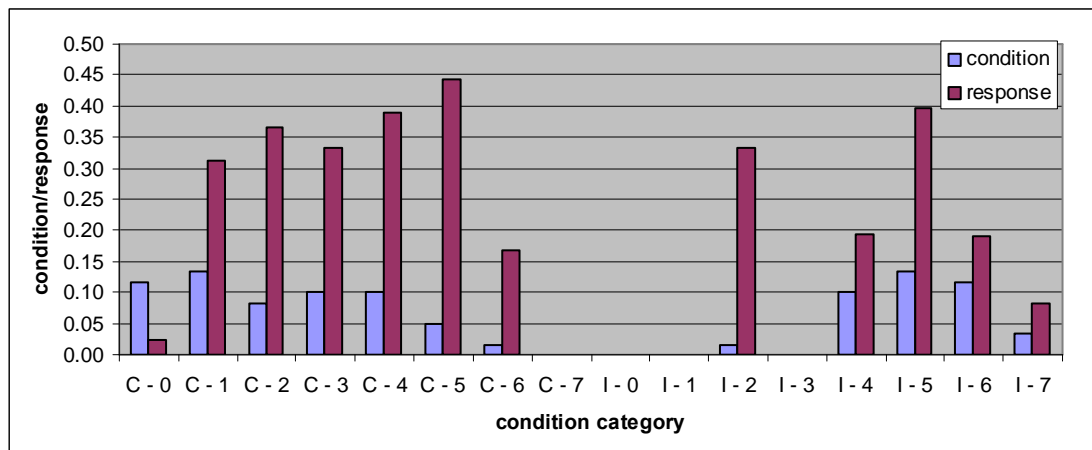
**Figure 13 Overall red gum condition and trajectory, Margooya Lagoon, Robinvale**

Blue bars are frequency of trees in each condition class (0-7, crown cover plus density score). Purple bars are mean response for each condition class (sum of three positive and three negative response variables scored as 0, scarce or absent; 1 present; 2 dominant). C = cracked bark, I = intact bark.

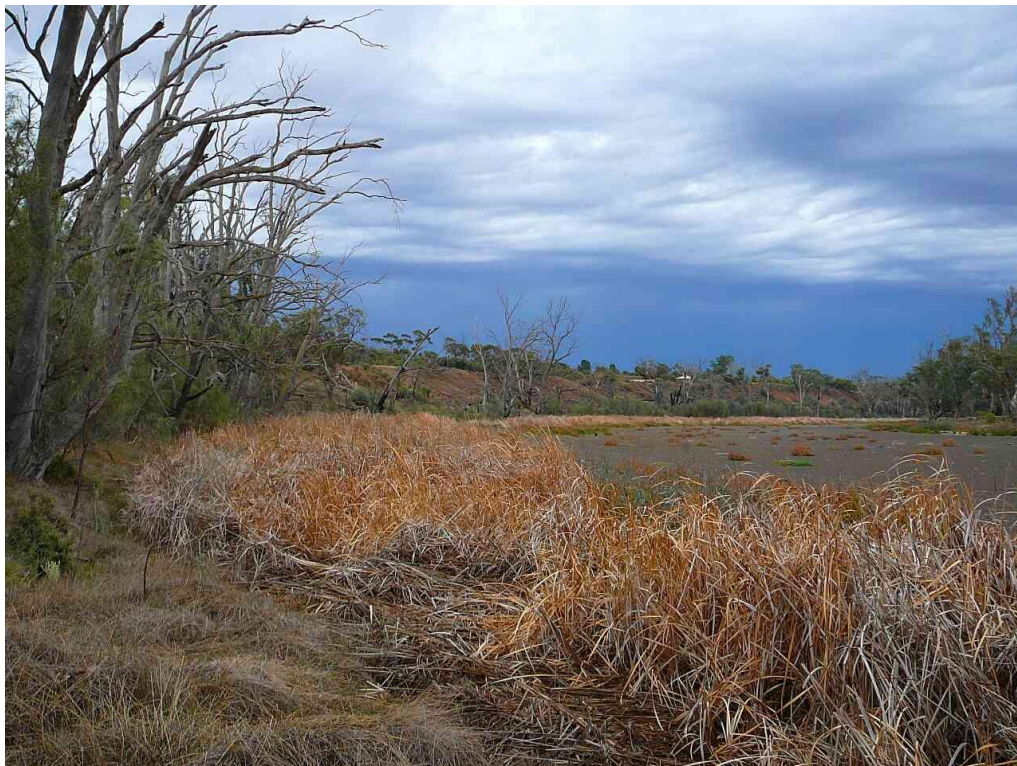
**Figure 22 Tree dieback at Margooya Lagoon (easting 669708 northing 6165602)**

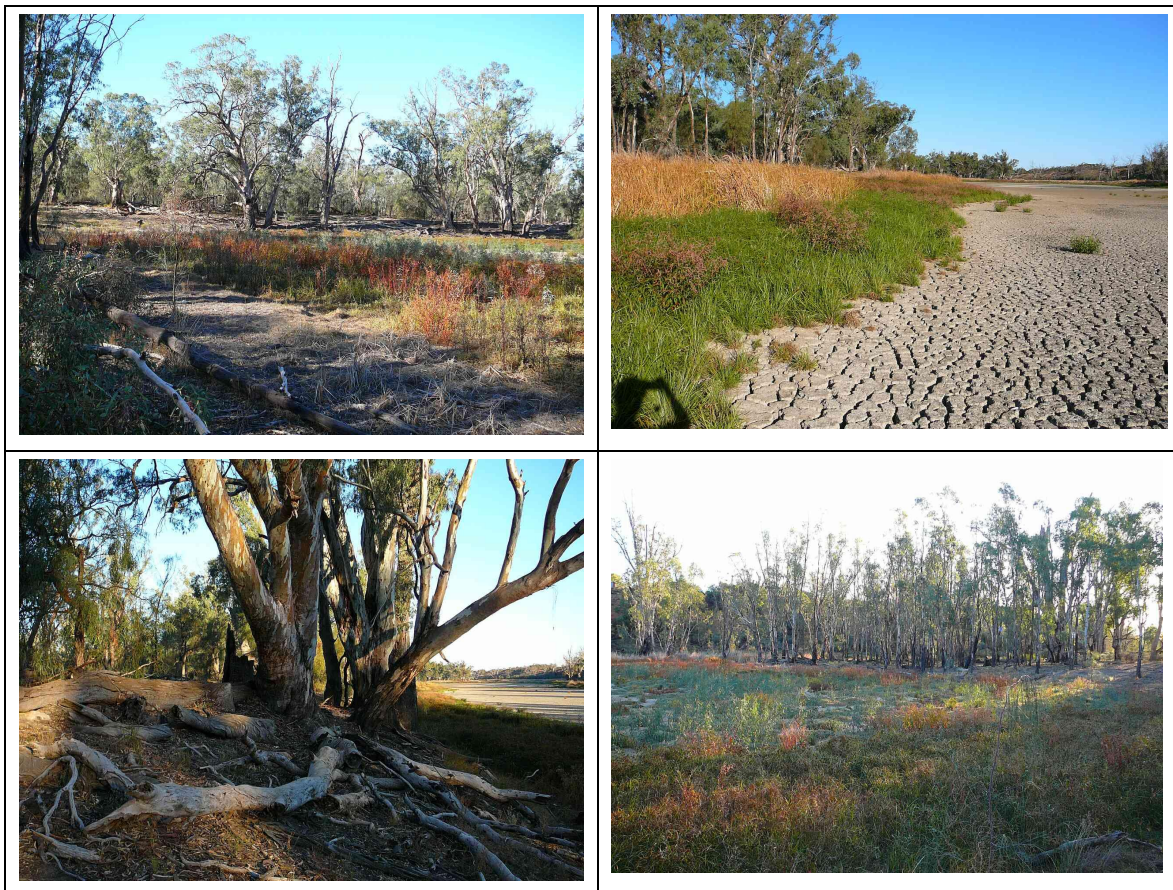
### 4.1 Margooya Lagoon – Habitat Assessment and Fauna Survey Site 1

Trees within this site are in variable condition, with some appearing relatively healthy, while others are exhibiting varying degrees of dieback. This could be attributed to the natural ageing process in some cases, but is more likely to be related to high salt levels in the soil and possibly seepage of saline irrigation water from nearby agricultural properties to the west of the lagoon. A light salt crust and salty aroma was noted on walking out onto the wetland bed. The Mallee CMA is closely monitoring salt levels in the remaining residual pools of water in the wetland and is prepared to reintroduce water to the wetland to neutralise these impacts if necessary (R. De Groot pers. comm.).

This site exhibits relatively good connections to other fauna habitats in the area; however, agricultural land to the west is in close proximity and interferes with the Murray River riparian vegetation corridor. There is good connectivity to the east of the lagoon however.

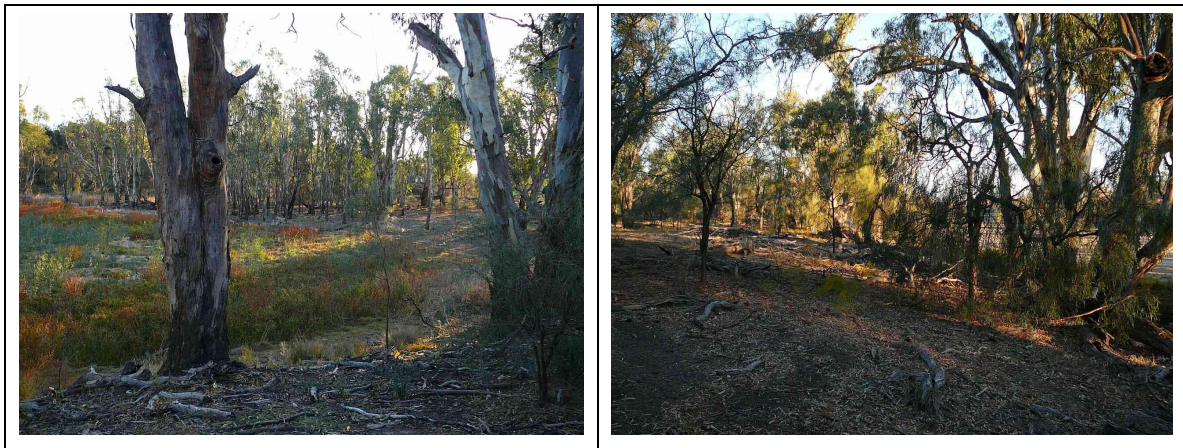
## 4.2 Margooya Lagoon – Habitat Assessment and Fauna Survey Site 2

Similar to Site 1, the primary habitat feature relates to abundant very large hollow-bearing River Red Gum (*Eucalyptus camaldulensis*) trees, with many hollows both within the trunk and limbs. Woody debris was also noted as abundant, with many large branches also containing hollows. Scattered River Cooba (*Acacia stenophylla*) was present, although only very sparsely scattered throughout. Dense Cumbungi (*Typha* sp.) was present in clumps along the wetland inner fringe, although this was beginning to brown off and die in some places due to the recent drying of Margooya Lagoon. Tree health was again variable, with some trees in seemingly good health and others in severe stages of decline. This may be due in part to saline groundwater impacts that are being monitored by the Mallee CMA, but in some cases could be natural decline from old age in a number of extremely large River Red Gums.

- » High numbers of large trees (primarily River Red Gum);
- » High abundance of hollows (primarily located within the trunk and branches of River Red Gum);
- » Moderate to high levels of woody debris;
- » Low abundance of large stags;
- » Moderate structural diversity;
- » Moderate leaf litter levels;
- » High connectivity to other fauna habitats (habitat connectivity on all sides).

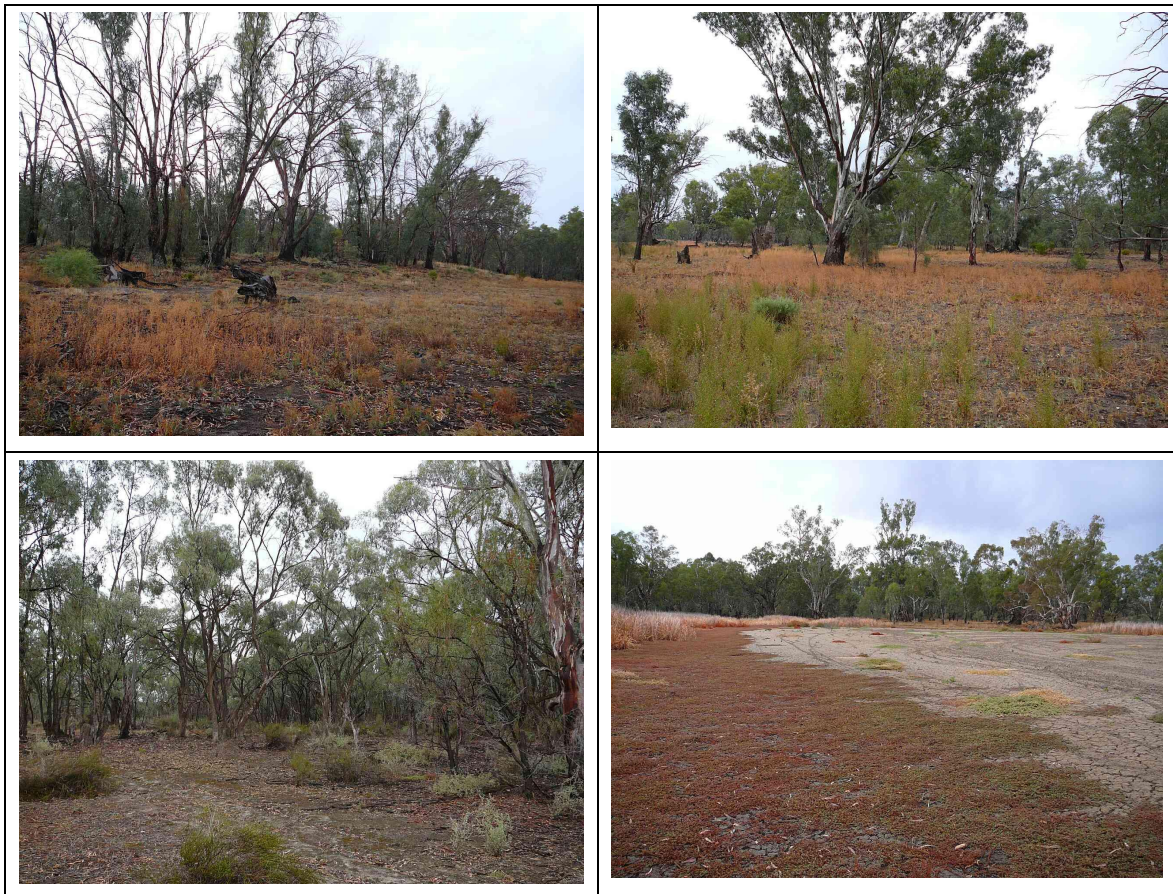
### 4.3 Margooya Lagoon – Habitat Assessment and Fauna Survey Site 3

This site is generally in relatively poor condition overall, with numerous River Red Gum (*Eucalyptus camaldulensis*) trees in poor health (e.g. exhibiting limb loss, cracking bark, loss of leaves), both along the fringe of the wetland and in isolated stands. This may be due to saline groundwater influences, or a range of other factors including the impacts of permanent wetland inundation. Some localised degradation of River Red Gum trees was noted on the upper bank of the wetland, but on closer inspection may have been the result of a fire. Fauna habitats are available, although less abundant than Sites 1 and 2 as the canopy vegetation is less dense, with fewer hollows, fewer large trees and lower levels of woody debris on the ground. The Black Box woodland further inland from the wetland fringe appeared to be supporting particularly high numbers of certain species of bird, including the Yellow subspecies of the Crimson Rosella (*Platycercus elegans*), Regent Parrot (*Polytelis anthopeplus*) and White-plumed Honeyeater (*Lichenostomus penicillatus*).

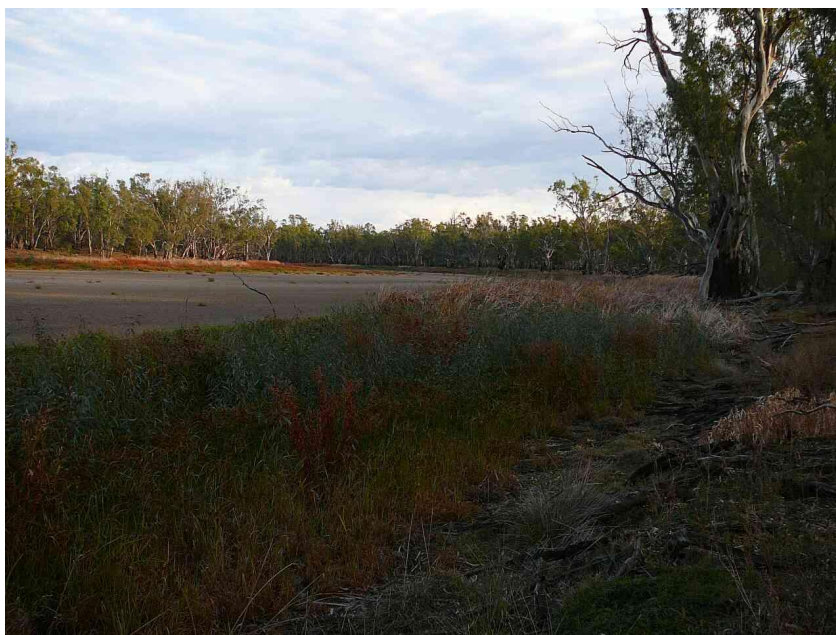
**Figure 23** Photo point 15 (669387, 6166130), from south bank of northeast ‘arm’ of wetland, looking north-east to monitor abundance of Cumbungi (*Typha* sp.) and condition of River Red Gums (*Eucalyptus camaldulensis*).

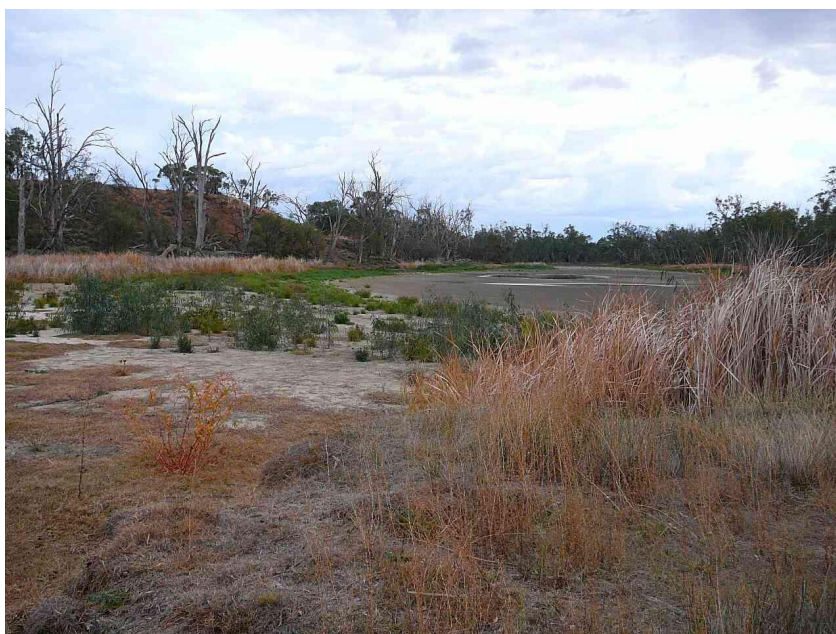
**Figure 24** Photo point 16 (N) (669393, 6166139), looking north toward the north-western ‘arm’ of wetland to monitor abundance of Cumbungi (*Typha* sp.) and condition of River Red Gums (*Eucalyptus camaldulensis*).

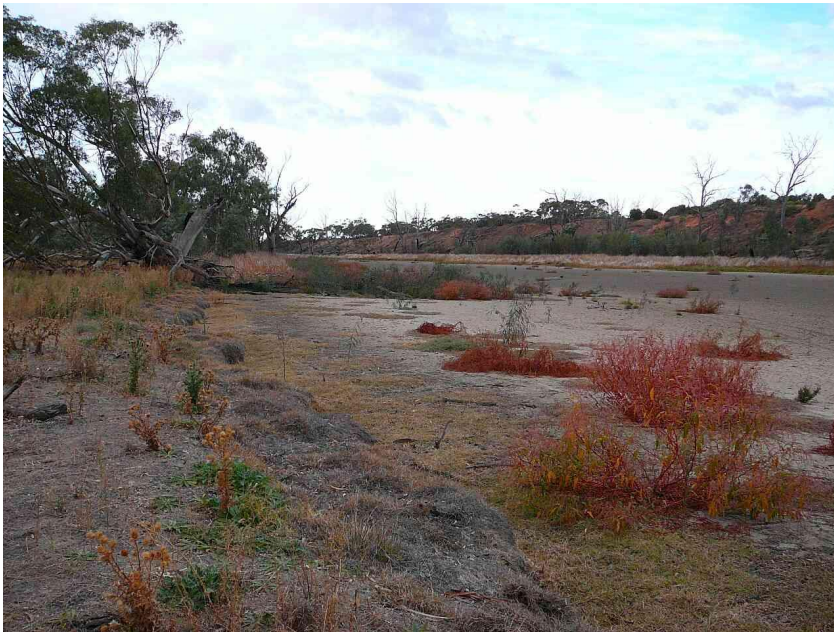
**Figure 25** Photo point 16 (S from same point as above) (669387, 6166130), looking south toward the southern ‘arm’ of wetland to monitor condition of River Red Gums (*Eucalyptus camaldulensis*) and terrestrial vegetation.

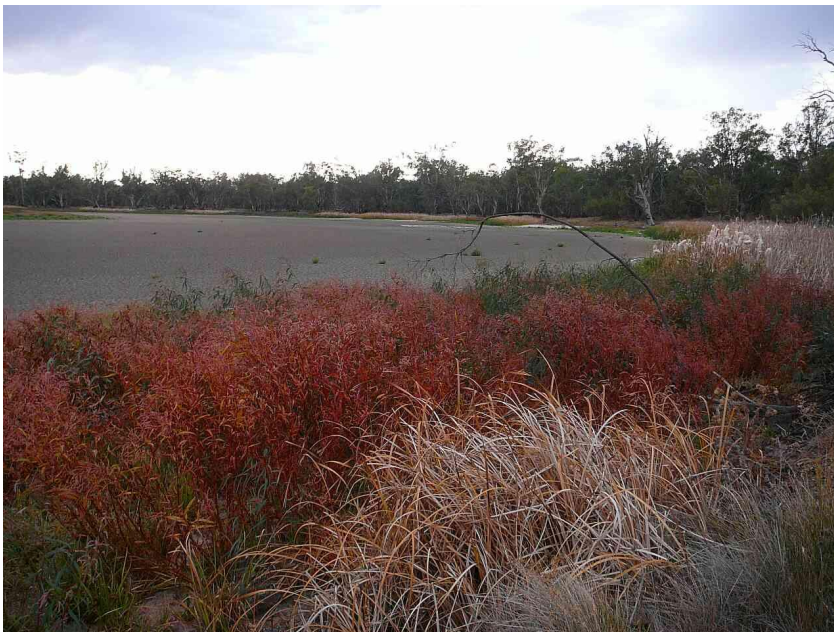
**Figure 26** Photo point 17(669789, 6166387), looking northeast toward the north-eastern ‘arm’ of wetland to monitor abundance of Cumbungi (*Typha* sp.)

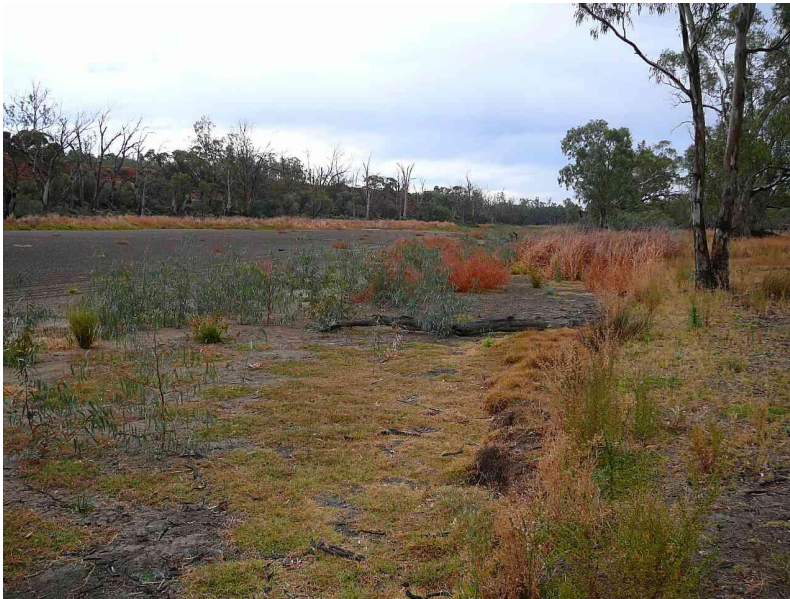
**Figure 27** Photo point 18 (669451, 6165943), looking north along the southern ‘arm’ of wetland to monitor abundance of Cumbungi (*Typha* sp.) and condition of River Red Gums (*Eucalyptus camaldulensis*).

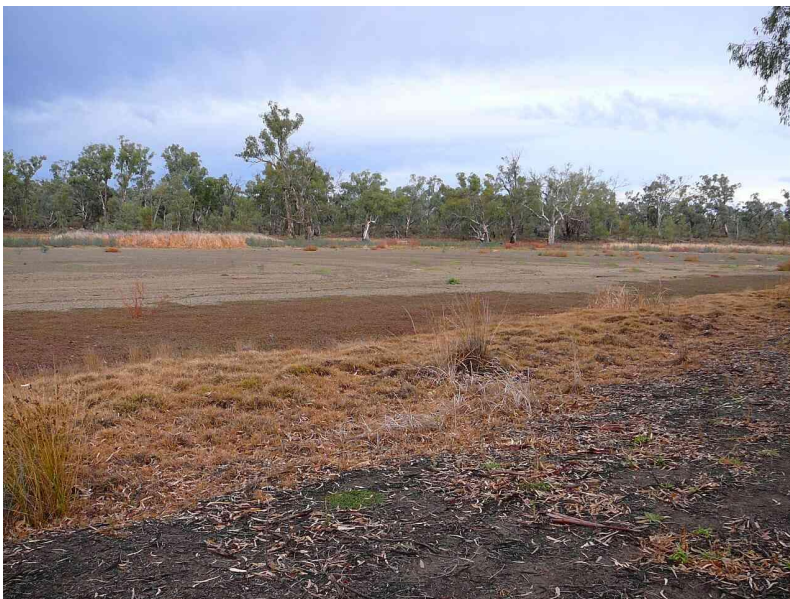
**Figure 28** Photo point 19 (669818, 6165879), looking south across the southern ‘arm’ of wetland to monitor abundance of Cumbungi (*Typha* sp.), condition of River Red Gums (*Eucalyptus camaldulensis*) and terrestrial vegetation.
