# **Abbotsford Bend and Darling Junction Environmental Water Management Plan**

Sunraysia Environmental (2016) Abbotsford Bend and Darling Junction Environmental Water Management Plan, Sunraysia Environmental for Mallee Catchment Management Authority Mildura, Victoria.

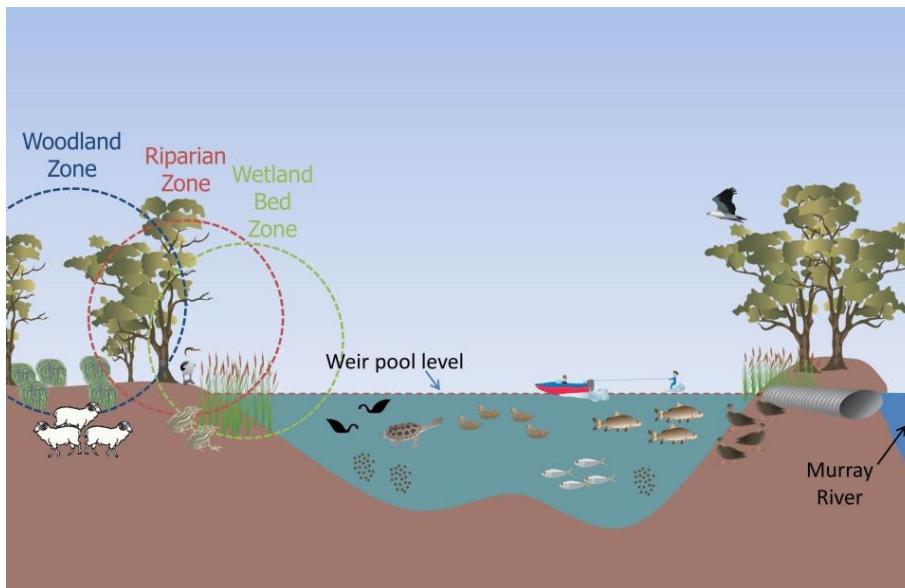
Figure 2. Conceptualisation of Cowra Rocks

Listed Water Dependent Fauna	Water Dependent Flora
Murray-Darling Rainbowfish	River Red Gum
Pied Cormorant	Cumbungi
Murray River Turtle	Lignum
<b>Wetland Fauna</b>	<b>Threats</b>
Native Fish	Sediment
White-bellied Sea-eagle	Grazing
Frogs	Common Carp
Grazing Waterfowl	Piped Track Crossing
Dabbling & Diving Ducks	<b>Activities</b>
Small Waders	Ski Tournaments & Practice
Large Waders	<b>Processes</b>
<b>Proposed Infrastructure</b>	Egg Banks Produced
Regulator	Exposure of Tubers and Roots
	Nutrient Cycling
	Plant material & detritus

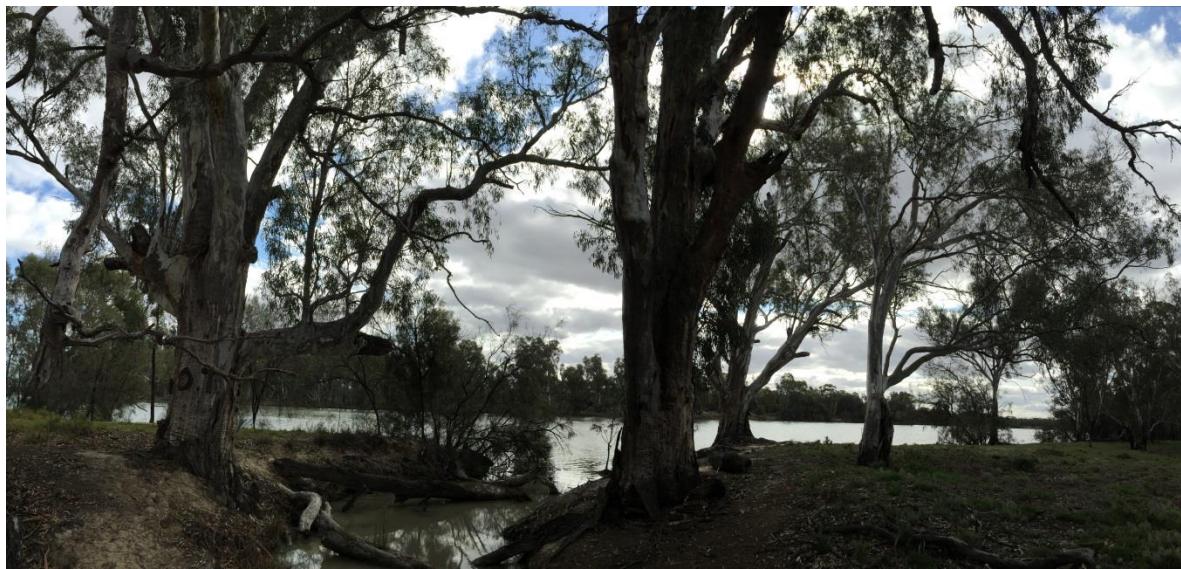
**Figure 7. The inlet channel to Cowra Rocks (Murray River in the middle distance).**

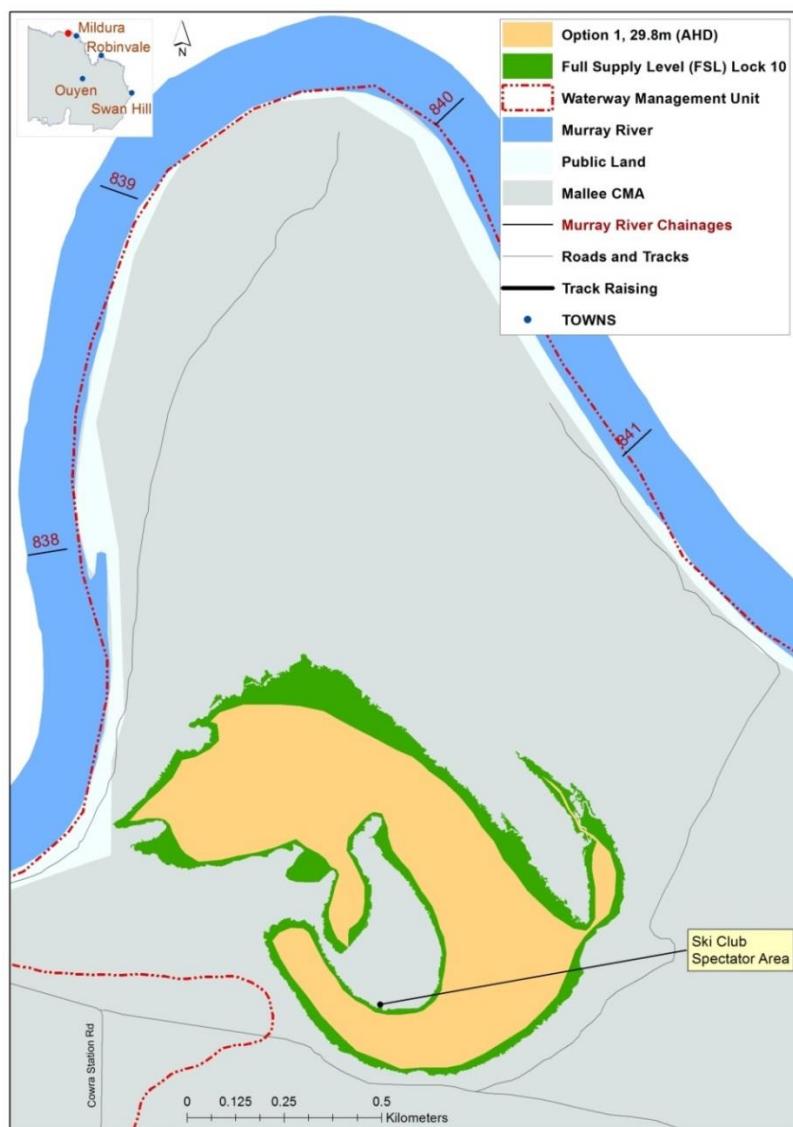
**Figure 8. Target area at Cowra Rocks – Option 1**

(Drawdown area shown is an example only, and not derived from data. A bathymetric study is required to determine extent and volume for draw down).

Refilling of the wetland to normal Lock 10 operating level (30.8 m AHD) could be achieved by opening the regulator. This option may not require delivery of environmental water; it may be possible to utilise normal river operations to refill the wetland, but may be dependent on timing (early spring). This option is also dependent on consultation with Ski Club representatives.

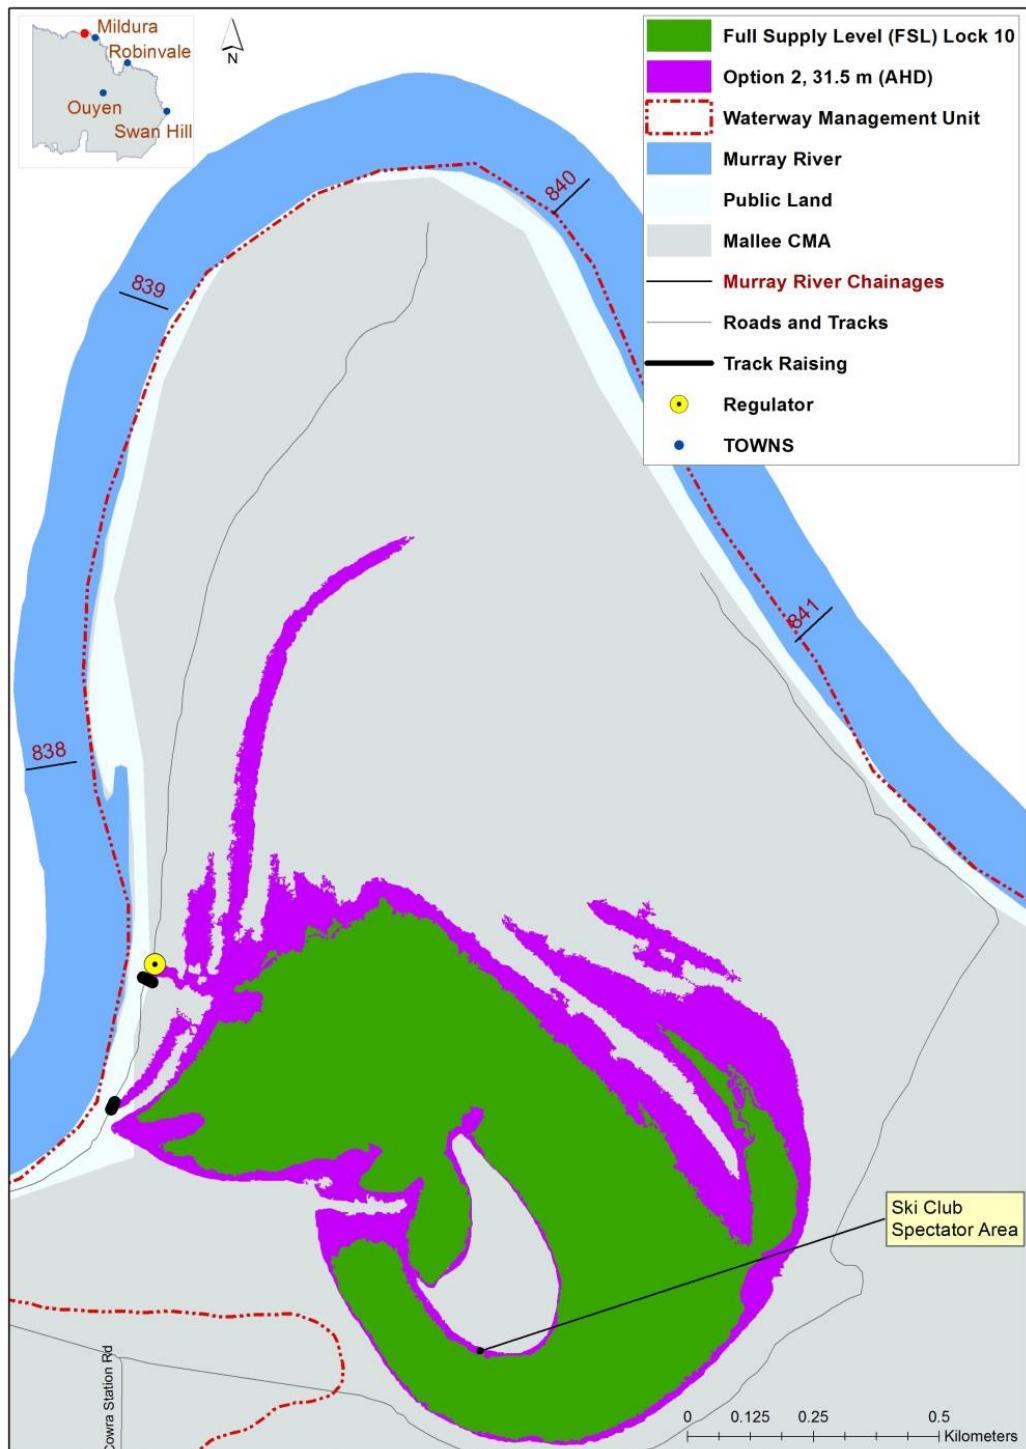
Figure 9. Target area at Cowra Rocks – Option 2

Option 2 (Figure 9) involves inundation of approximately 32 ha of fringing riparian zone and woodland vegetation requiring approximately 550 ML of environmental water, delivered using a temporary diesel pump that would pump from the Murray River, over the regulator, into the inlet channel, raising the level in Cowra Rocks to 31.5 m AHD. This option is also dependent on consultation with the Ski Club. Road raising is required at two sites to prevent break out to the Murray River, and potentially on a separate track if the Ski Club requires access to an existing spectator area (Figure 9).

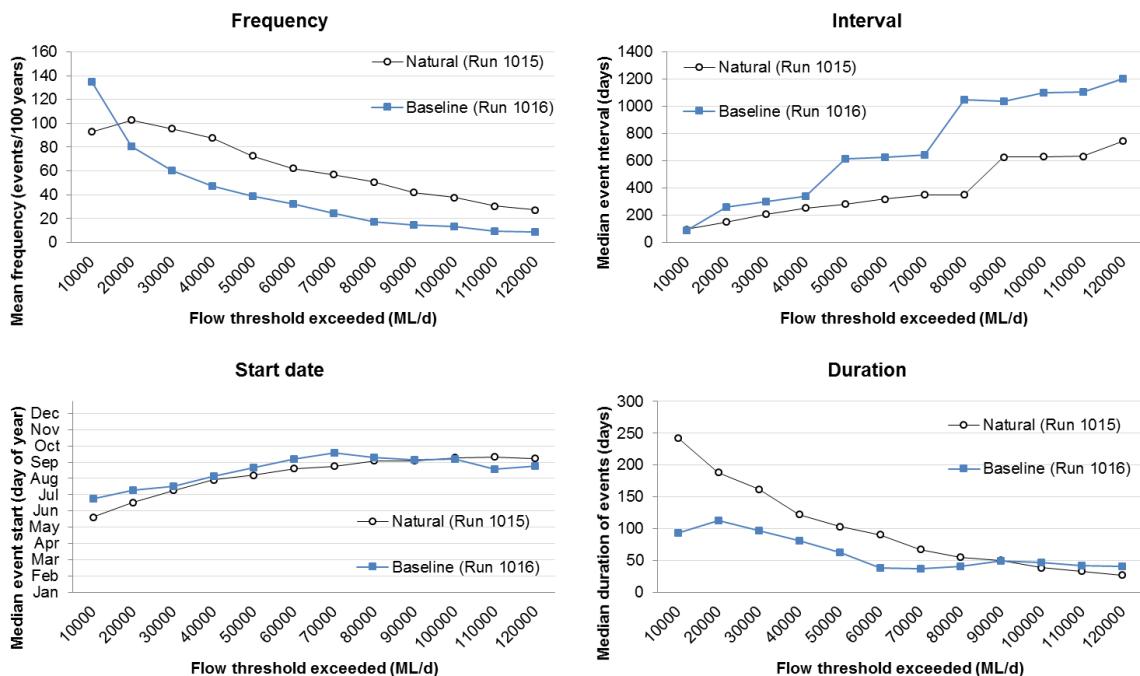
**Figure 10. Comparison of Natural (pre-regulation) and Baseline Modelled Flow (post-regulation) scenarios for Euston Downstream (Gippel, 2014).**

A comparison of daily discharge by month for the pre-regulation and post-regulation (current) conditions for Euston Downstream is reproduced from Gippel (2014) (Figure 10) and Ecological Associates (2007c) (Figure 11) and indicates both the magnitude and frequency of large flood events has reduced. Additionally, almost constant inundation at Cowra Rocks has reduced the capacity for the wetland to contribute to valuable ecosystem services.

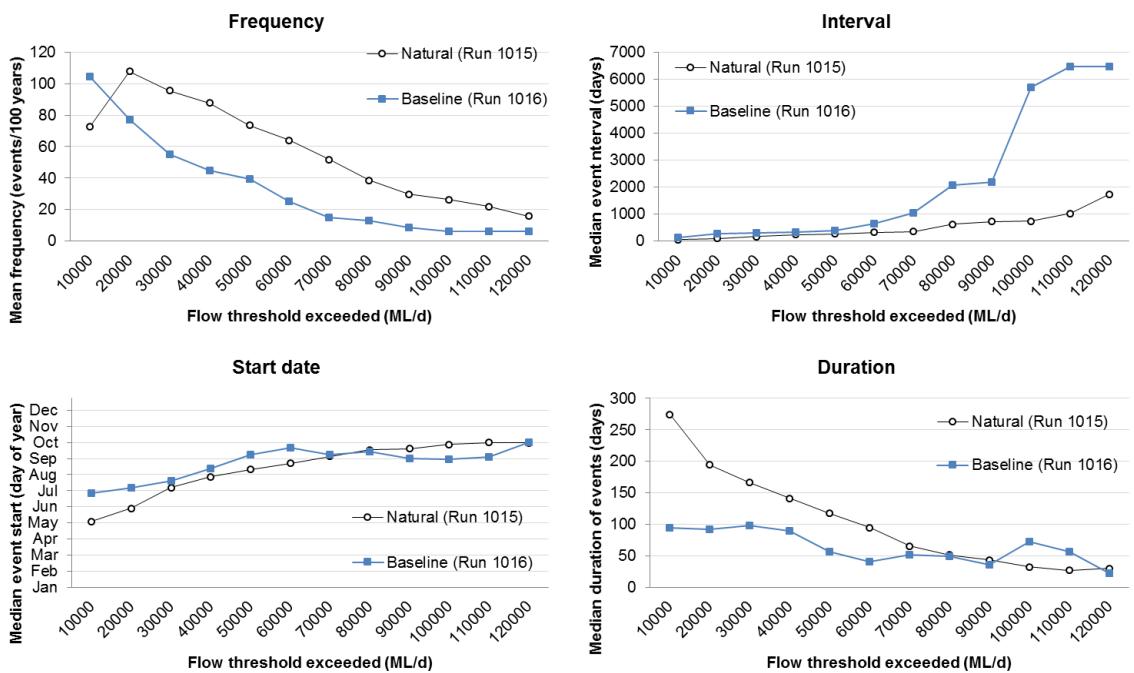
**Figure 12. Comparison of Natural (pre-regulation) and Baseline Modelled Flow (post-regulation) scenarios for Lock 9 upstream (Gippel, 2014).**

Similarly, a comparison of daily discharge by month for the pre-regulation and post-regulation (current) conditions for Upstream Lock 9 is reproduced from Gippel (2014) in Figure 12 for Darling Junction, also indicating reduced magnitude and frequency of large flood events.

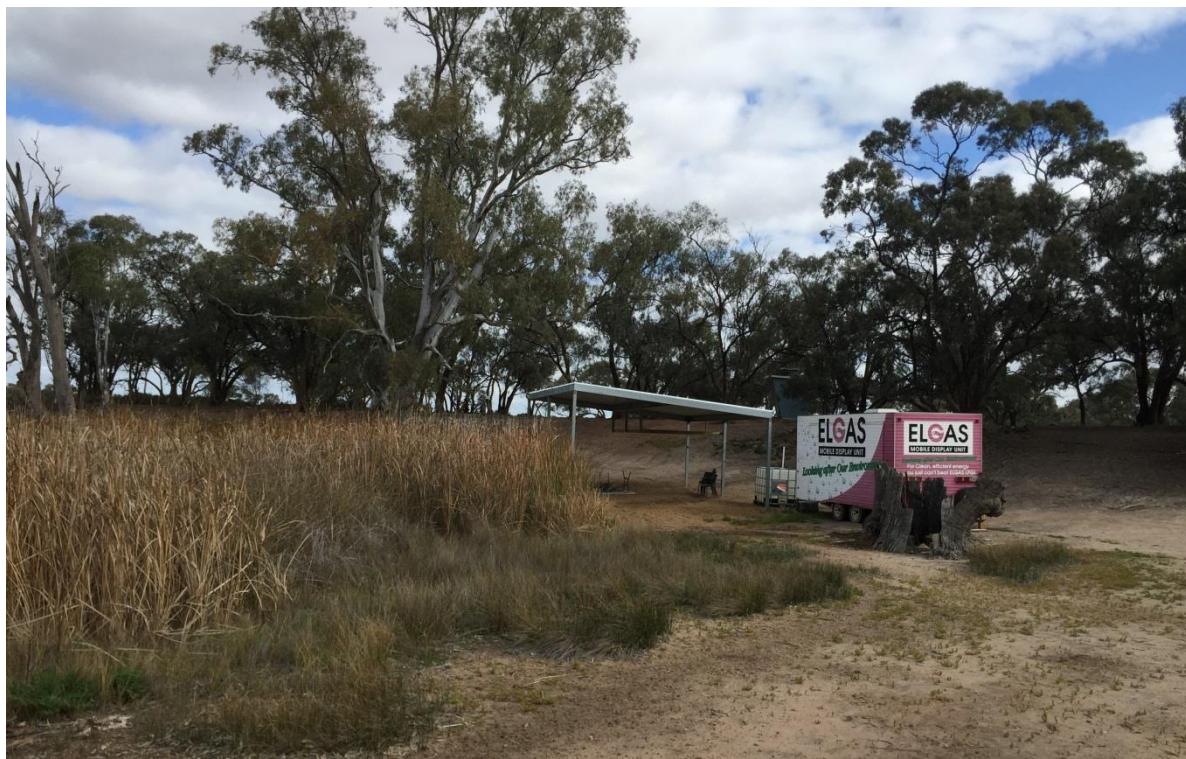
**Figure 16. Mildura Ski Club has some basic infrastructure on site at Cowra Rocks. The edge of the wetland is discernible by the line of Cumbungi left of centre.**

Cowra Rocks and surrounds have been used since 2007 by the Mildura Ski Club, which currently has a license agreement with the landholder. The wetland is available to all club members throughout the year, and is used frequently for tournaments and practice through spring, summer and autumn. A junior Ski School is conducted at the site each year during the Victorian September school holidays, and other major events are scheduled in mid-summer. Club infrastructure held on site includes a ski jump ramp, judging tower, under cover area, catering van (Figure 16) and storage facilities. Spectators watch from a viewing area on the central ‘island’ of Cowra Rocks, accessible via a narrow and low lying (31 m AHD) track.

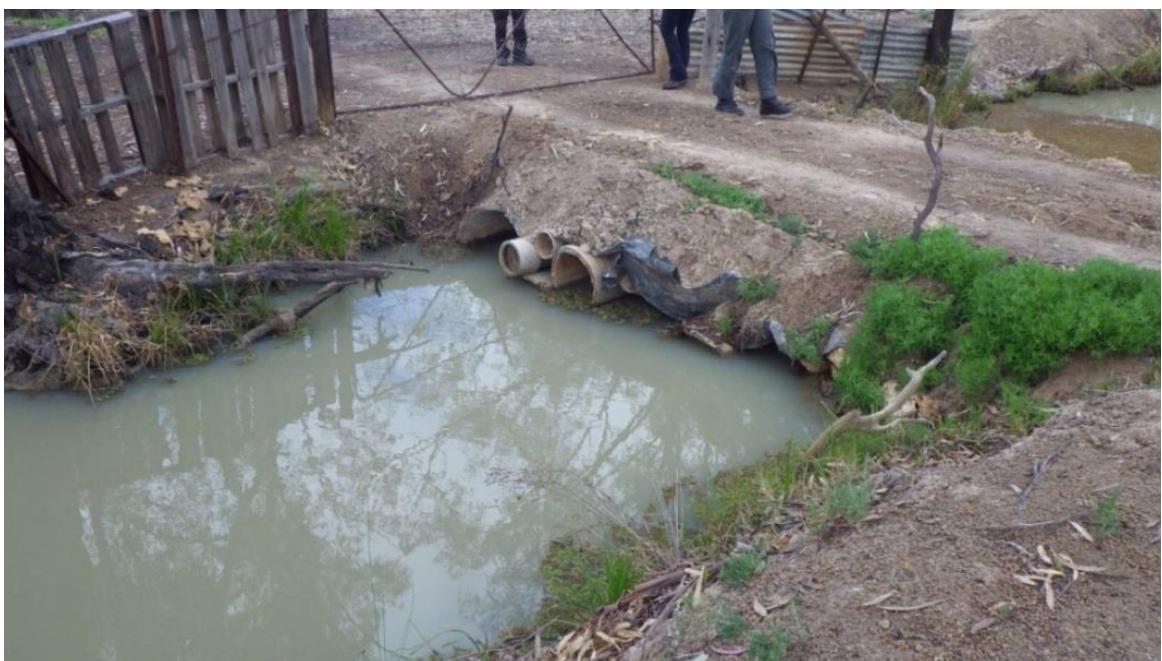
Figure 17. Track crossing at inlet to Cowra Rocks.

Cowra Rocks is permanently connected to the Murray River and the water level remains static under the influence of the Lock 10 weir pool. Movement of aquatic fauna is restricted; the narrow inlet channel is partially blocked by a track crossing of basic design (Figure 17). Restricting movement of fish populations may impede genetic diversity within Cowra Rocks (Faulks, Gilligan & Beheregaray 2011).

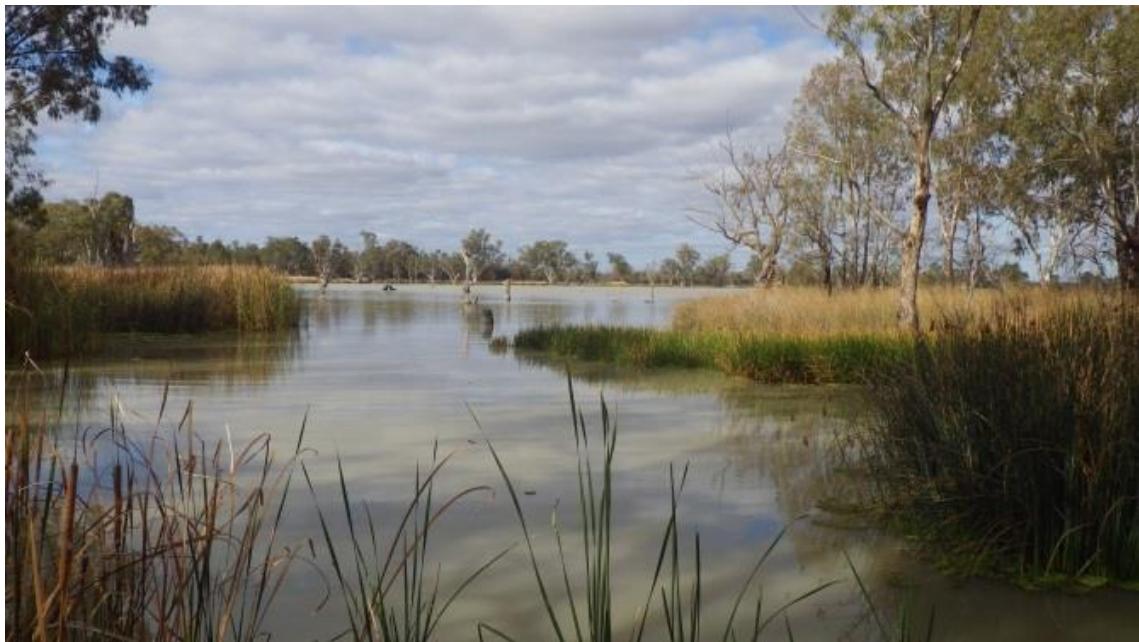
**Figure 18. Cumbungi dominates the shoreline in places**

In places, there is a dominance of Cumbungi around the edge of the Cowra Rocks wetland (Figure 18). Areas of surrounding Lignum have suffered from past dry periods (Figure 19).

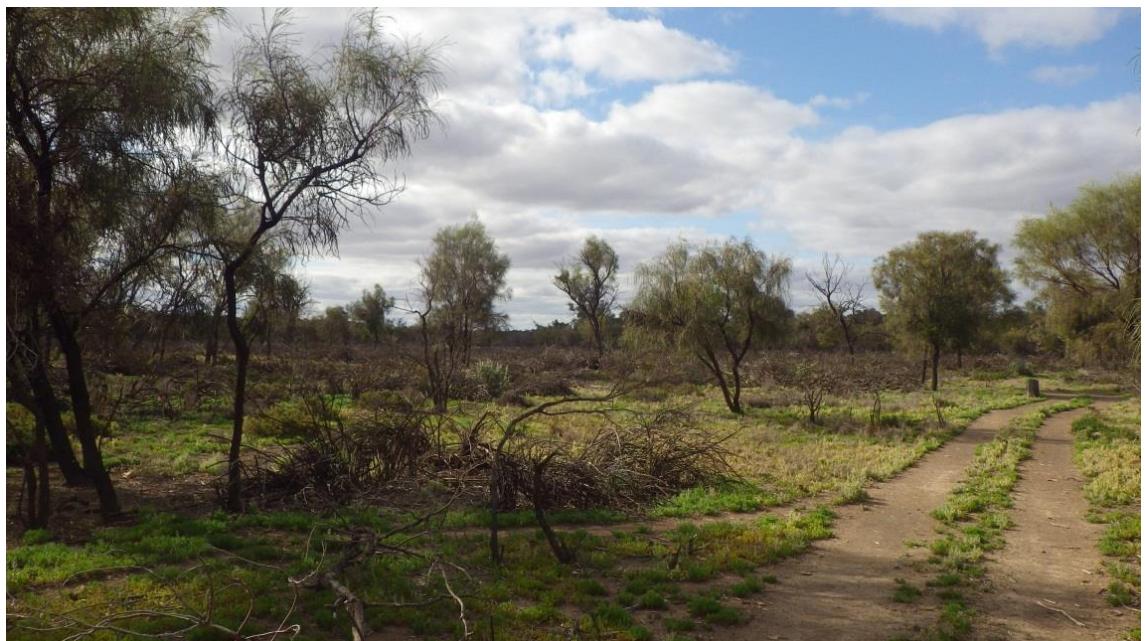
**Figure 19. The floodplain on the north west edge of Cowra Rocks comprises Lignum Swampy Woodland with an overstorey of *Acacia stenophylla*. Several stressed Lignum are visible in the foreground.**

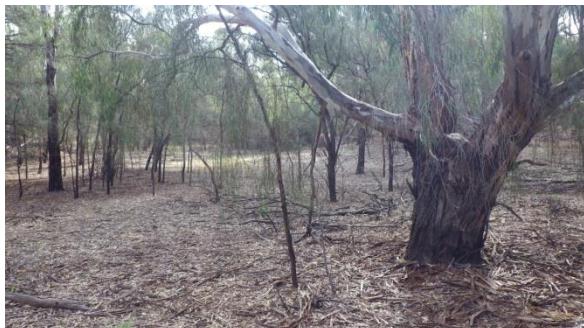
**Figure 20.** The Darling Junction Creek, looking west from the Lock 10 track crossing.

The Red Gum communities at Darling Junction appear to be in good condition with many age classes present (Figure 20), though there has been some invasion of terrestrial species across the water course (Figure 21).

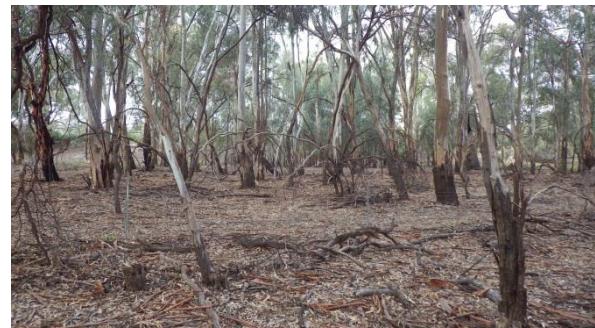
**Figure 21.** Photopoint CD01 image captured during rabbit monitoring (2015) on private land at the western end of Darling Junction.

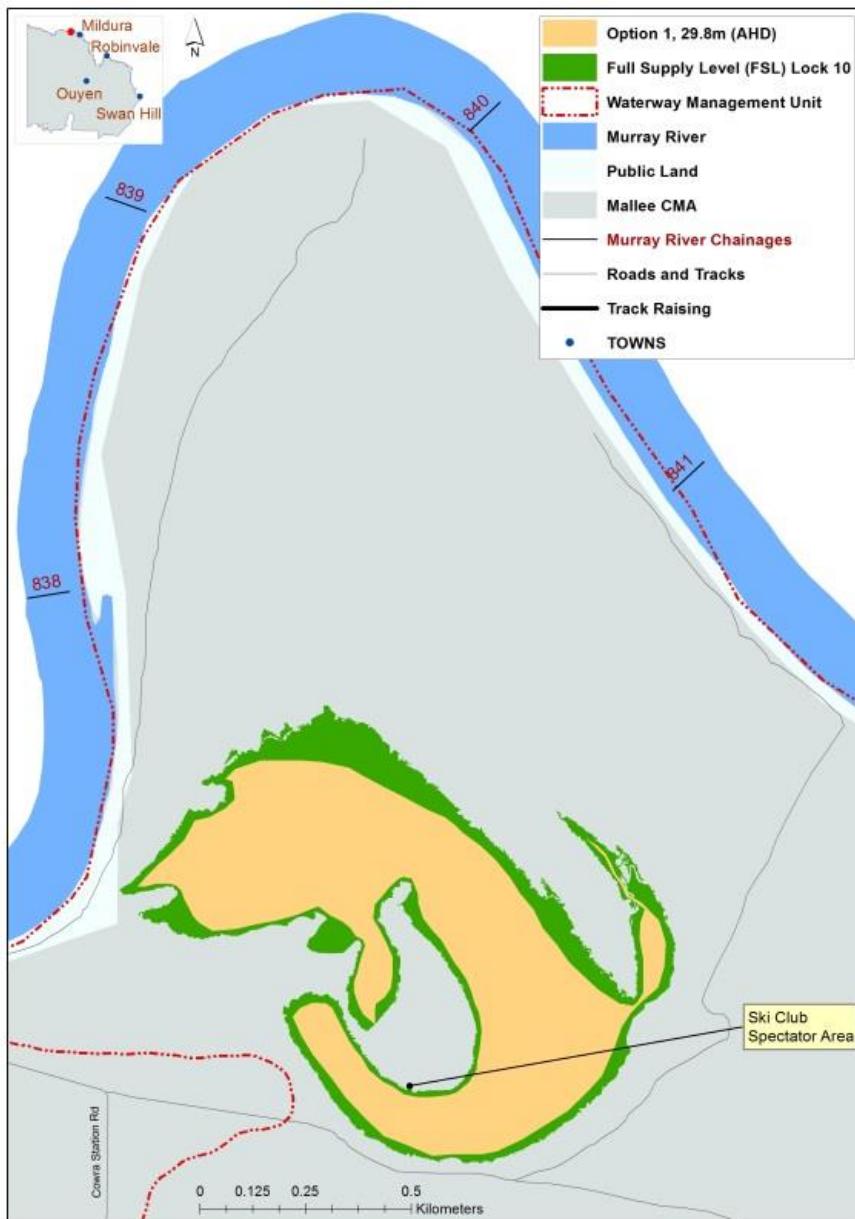
Figure 22. Target area at Cowra Rocks, Option 1: Drying Phase (estimated area)

It is estimated that between 300 and 500 ML of water would need to be pumped from Cowra Rocks to implement a 1 metre draw down. Further studies are required to refine these figures and identify the approximate drying zone.

Regime	Dry Down area, duration and frequency
Optimal	Reduce the water level at Cowra Rocks commencing in late Autumn by pumping. Reduce the water level in Cowra Rocks to approximately 29.8 m AHD twice in ten years with an interval of five years between events. Maintain the water level at 29.8 m AHD for up to three months, then allow to recharge slowly in late winter via the regulator to 30.8 m AHD to increase the diversity and extent of aquatic macrophytes fringing the wetland.

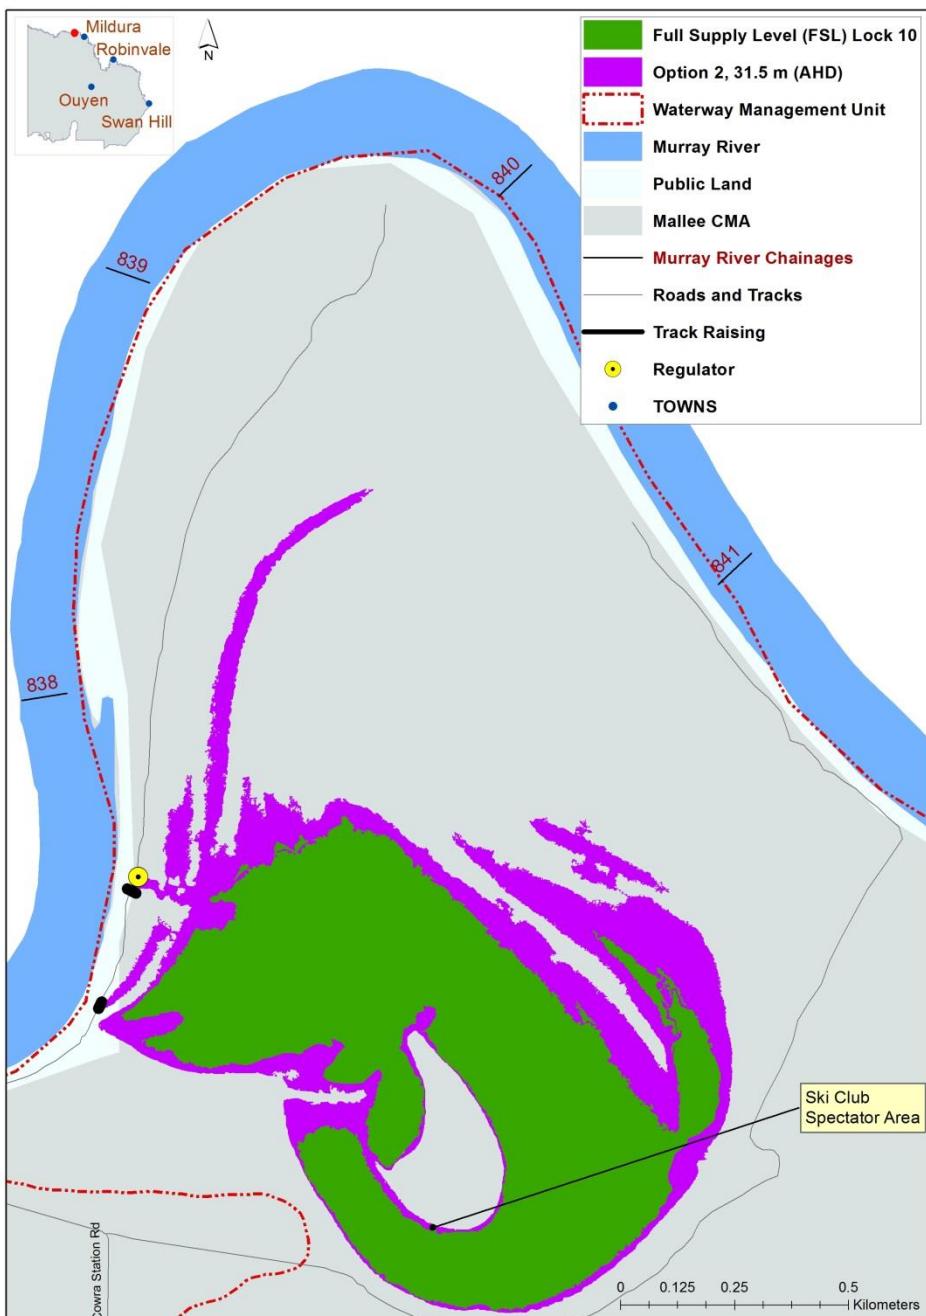
Figure 23. Target area at Cowra Rocks, Option 2: Inundation Phase

The Inundation Phase (Figure 23) involves the inundation of approximately 32 ha in addition to the existing wetland of 66 ha. This would require approximately 550 ML of environmental water. Water can be delivered to Cowra Rocks by pumping from the Murray River close to the proposed regulator site. In addition to the proposed regulator, track raising is required to retain water on the floodplain and efficiently inundate the target area (Figure 23). Infrastructure is described in more detail in section 8.0.

Water Regime	Inundation area, duration and frequency
Optimal	Inundate the area surrounding Cowra Rocks by pumping over the regulator structure to a height of 31.5 m AHD three years in ten with a maximum interval of seven years between events. Maintain water on the floodplain for at least four months to promote Lignum growth and recruitment and improve aquatic macrophyte diversity and extent before allowing natural recession through the Cowra Rocks regulator.

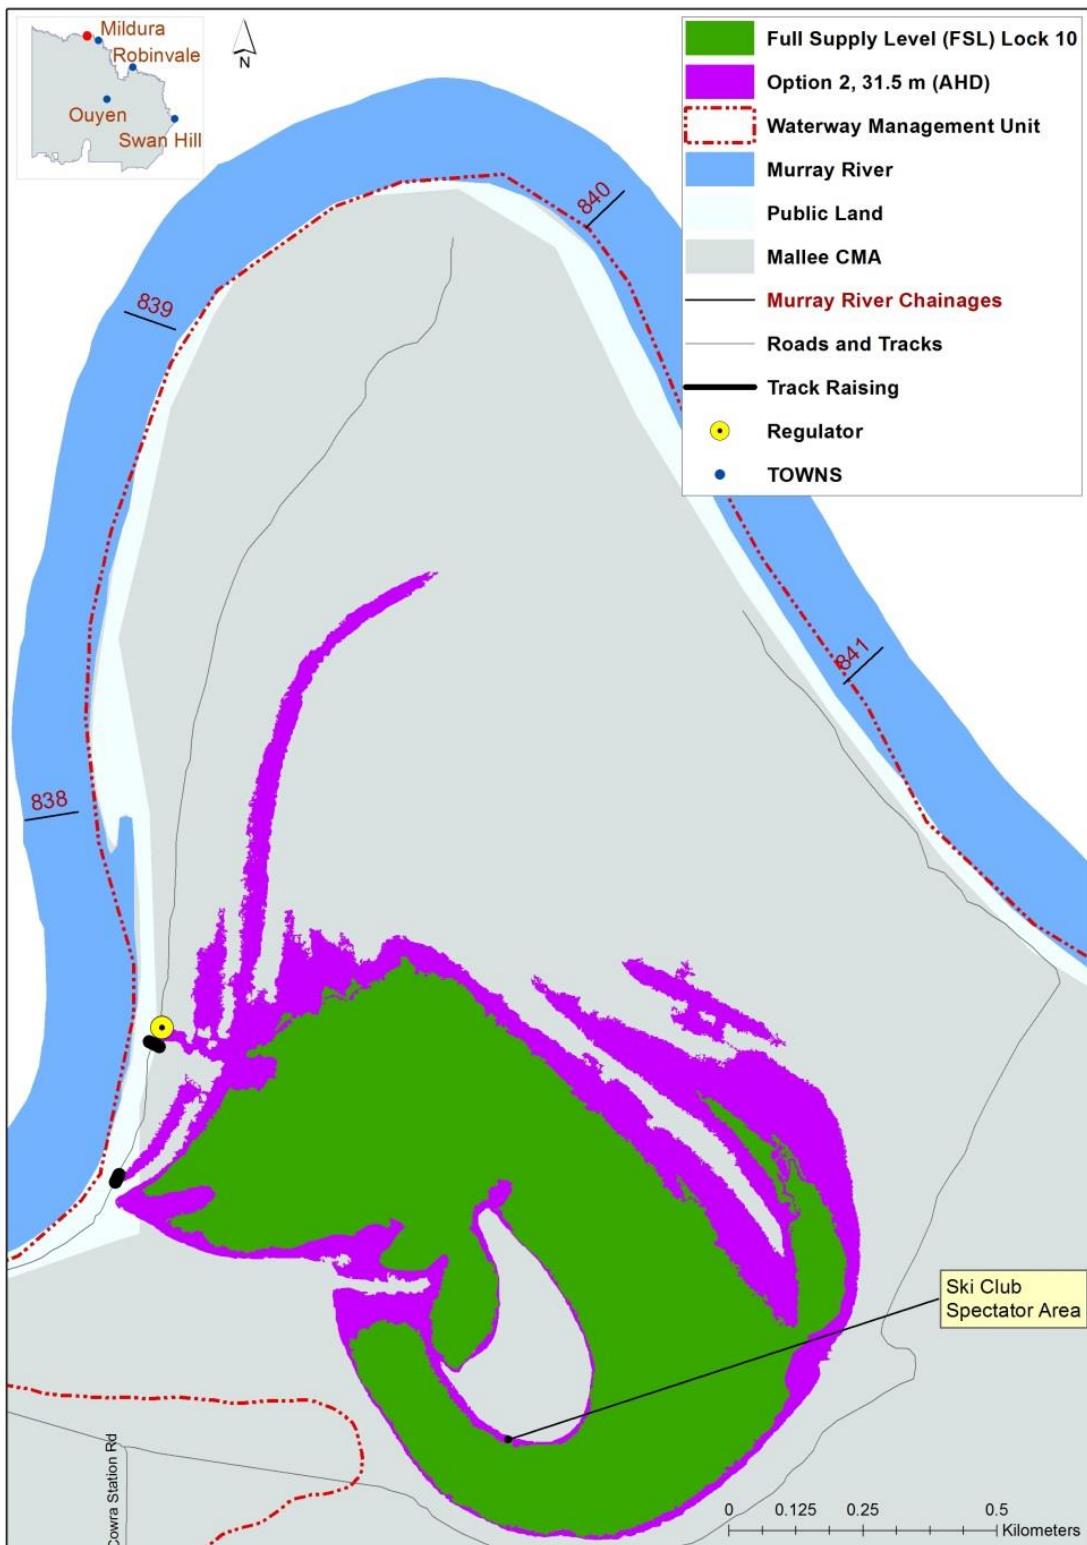
A concept design for a regulator structure and track crossing at the wetland inlet has been prepared (Alluvium 2007), however the track crossing on this design is built to a height of at 31.0 m AHD, which is 0.5 m below the targeted inundation height. A new regulator structure and track crossing would need to allow for adequate freeboard above 31.5 m AHD.

**Figure 24. Anticipated inundation extent (98 ha total) at Cowra Rocks Wetland, Option 2, with proposed infrastructure in place.**

Furthermore, if water was to be pumped from Cowra Rocks to the northern floodplain to inundate Lignum Swampy Woodland, minor earthworks are likely to be needed to prevent flow to the river and back into the wetland.

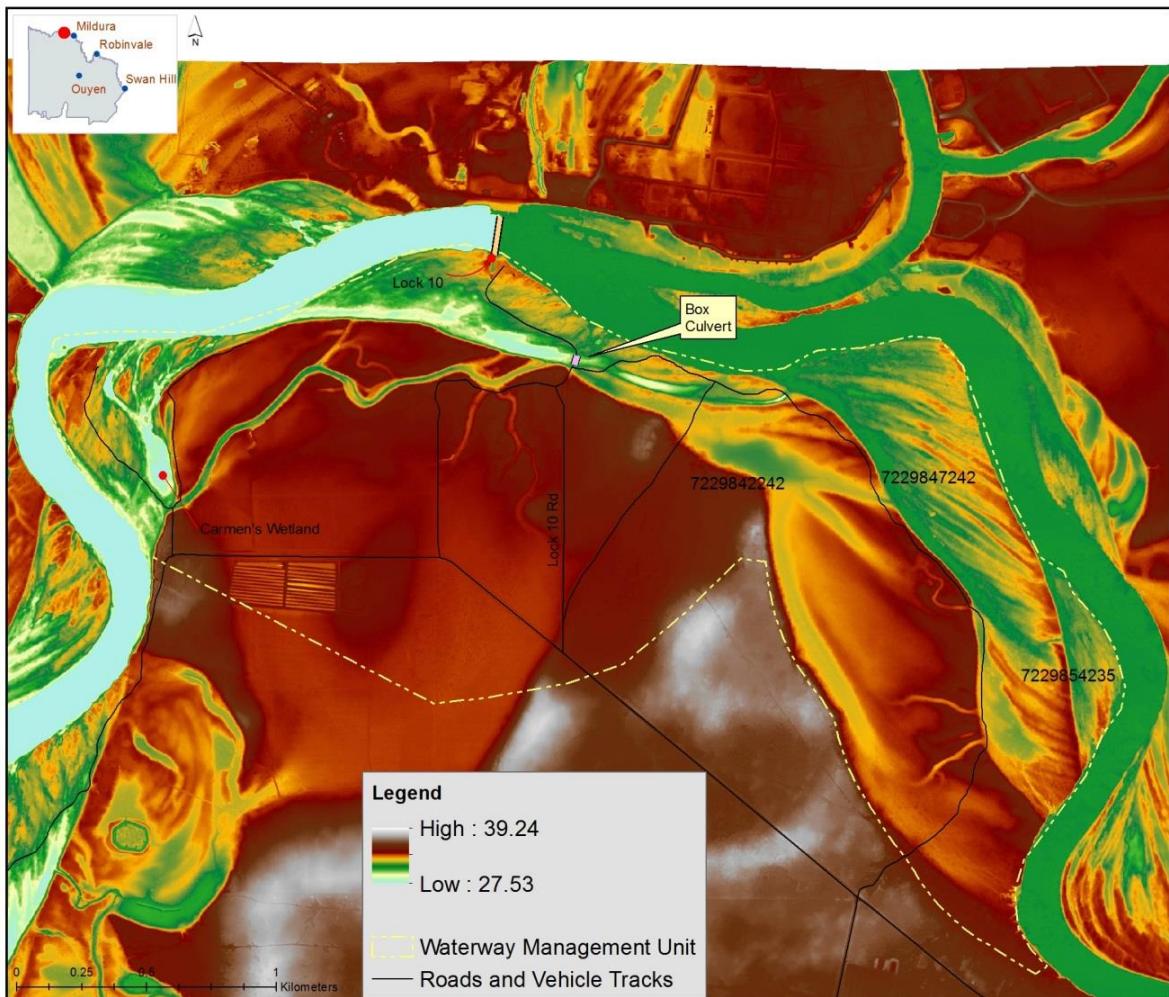
Figure 25. Location of proposed box culvert structure on Darling Junction Creeks.

Recommended works for Darling Junction include the installation of box culverts on the main anabranch of Darling Junction Creeks (Figure 25), replacing the causeway on Lock 10 Road. These works would remove a major impediment to the flow of water along the waterway, allowing free flow past the Lock 10 Road during a natural flood event. A concept design for a three culvert structure at the road crossing has been prepared (Alluvium 2007). The proposed works also allow for future environmental watering at the site, which is not proposed at this time due to the constraints described in the preceding section, the high cost of works, and the relatively small environmental benefit. Consideration of delivery of environmental water would require further investigation and cost-benefit analysis into the full scope of works that will be required to facilitate environmental flows along the watercourse.
