Neds Corner

Environmental Water Management Plan

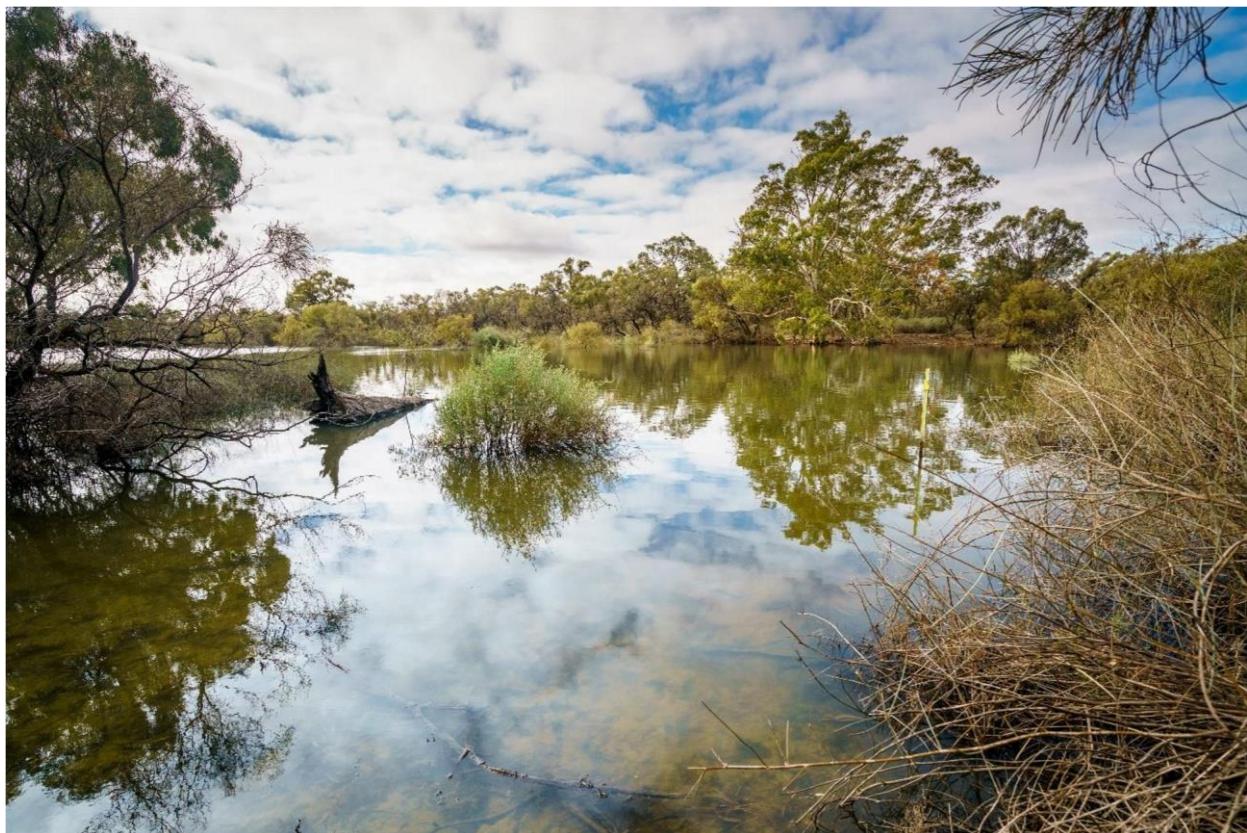
Figure 8. Environmental water delivered in 2016 to Neds East.

Environmental water will be pumped from the Murray River to Neds East and to Neds Central, with road raising to retain water within the wetlands. Approximately 100 ML of environmental water is proposed to be delivered to Neds East, and approximately 150 ML of water is proposed to be delivered to Neds Central. These volumes are based on experience from a previous environmental watering event during 2014/15. Delivery of environmental water is proposed to improve the Floodway Pond Herland EVC within Neds East, and to reinstate the Lignum Swamp EVC in Neds Central. Woolshed Creek received its first environmental water delivery of 20ML in 2019.

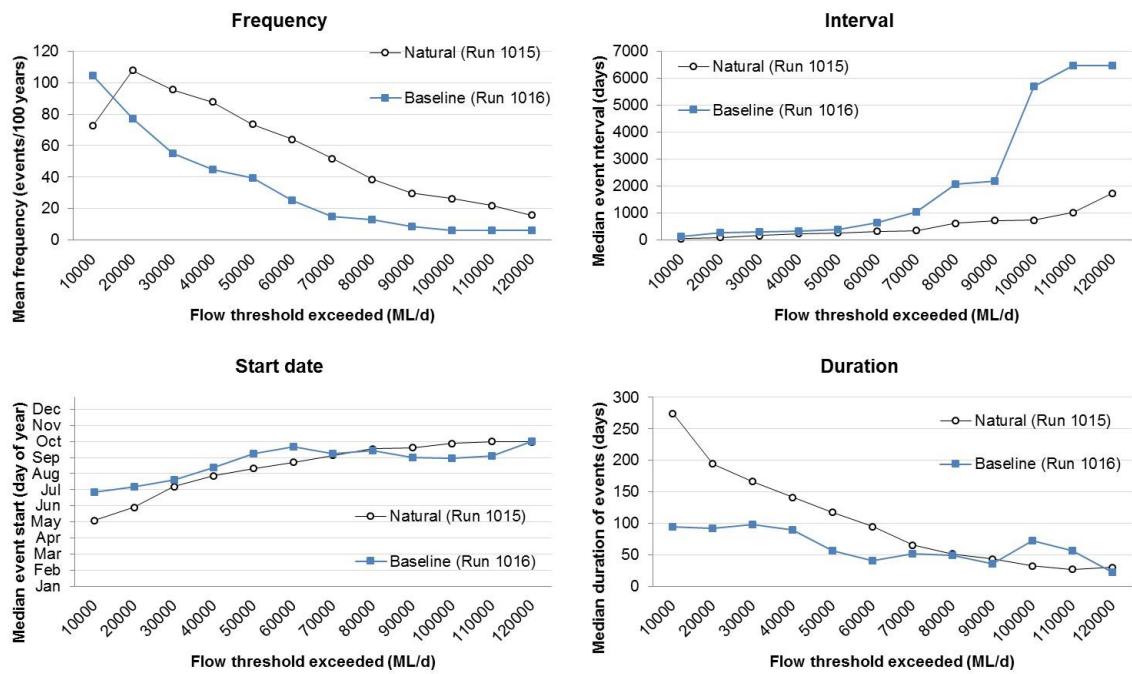
Figure 9. Comparison of Natural and Baseline Modelled Flow Scenarios for Lock 9 upstream (Gippel, 2014).

Spells analysis undertaken by Gippel (2014) was consulted to better understand the frequency of inundation of the Neds Corner wetlands under post-regulation conditions (Figure 9). The percentage of years with the threshold event of 50,000 ML/day from pre-regulation to post-regulation (baseline) have significantly reduced (approximately 50 per cent), and the durations of these events are also significantly reduced. The interval between events has also increased. This is shown in Table 3.

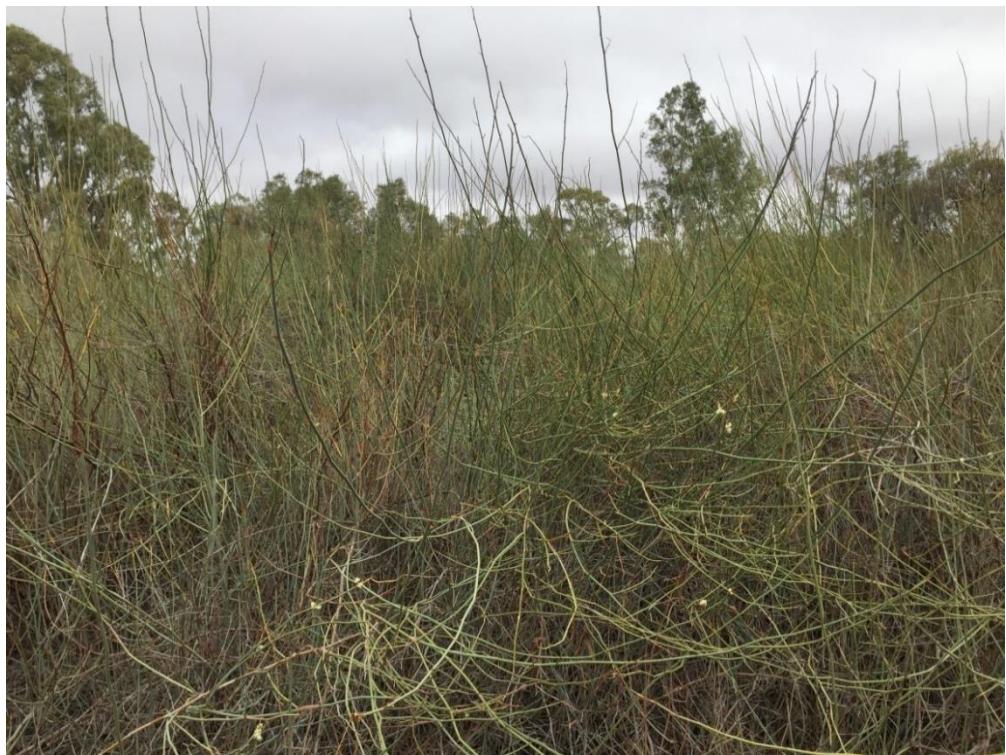
Figure 10. Strong growth occurred at Neds East after the 2015 watering event. This image captured 11 April 2016.

Significant vegetation response was evident after the 2015 event, with a flourish of strong growth exhibited by Lignum located in the north of the Neds East target area (Figure 10).

Neds East has responded well to several years of environmental water delivery. Lignum stands have exhibited strong growth (Figure 10, page 18). Tree canopies and the wetland bed has showed signs of positive vegetative response within the woodland and herbland EVCs, with good coverage of herbs and forbs that dry off over the summer (cover image; Figure 17).

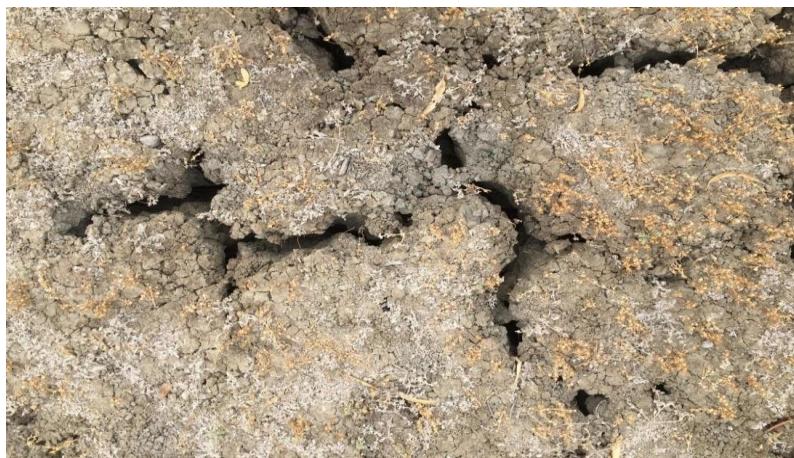
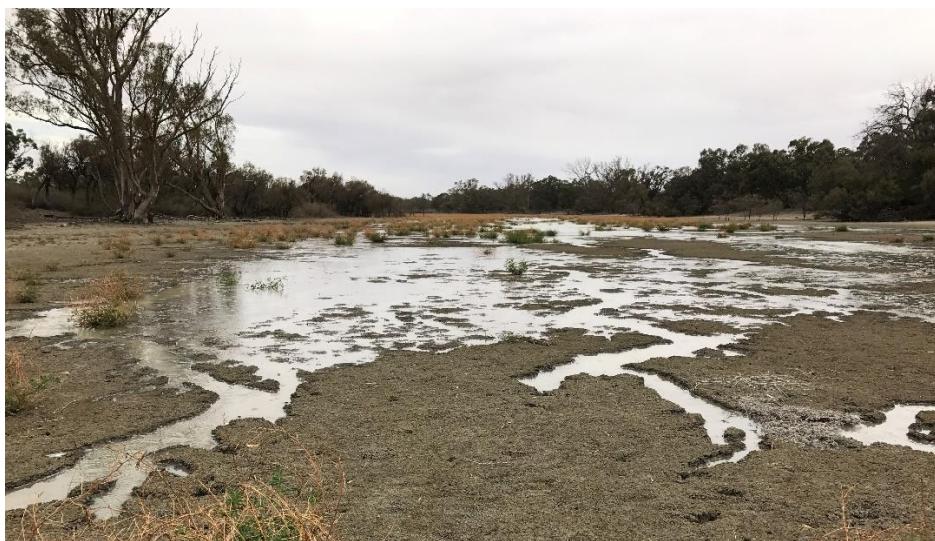
Figures 12a/b. The soils in parts of Neds East exhibit significant shrink-swell characteristics, as evidenced in the top image, captured April 2016, with some cracks measuring 50 mm across. Water movement along these cracks was demonstrated, bottom image, during delivery at Neds East in Oct 2019. These soils may provide habitat for the near threatened Giles Planigale and the critically endangered De Vis' Banded Snake recorded at Neds Corner.

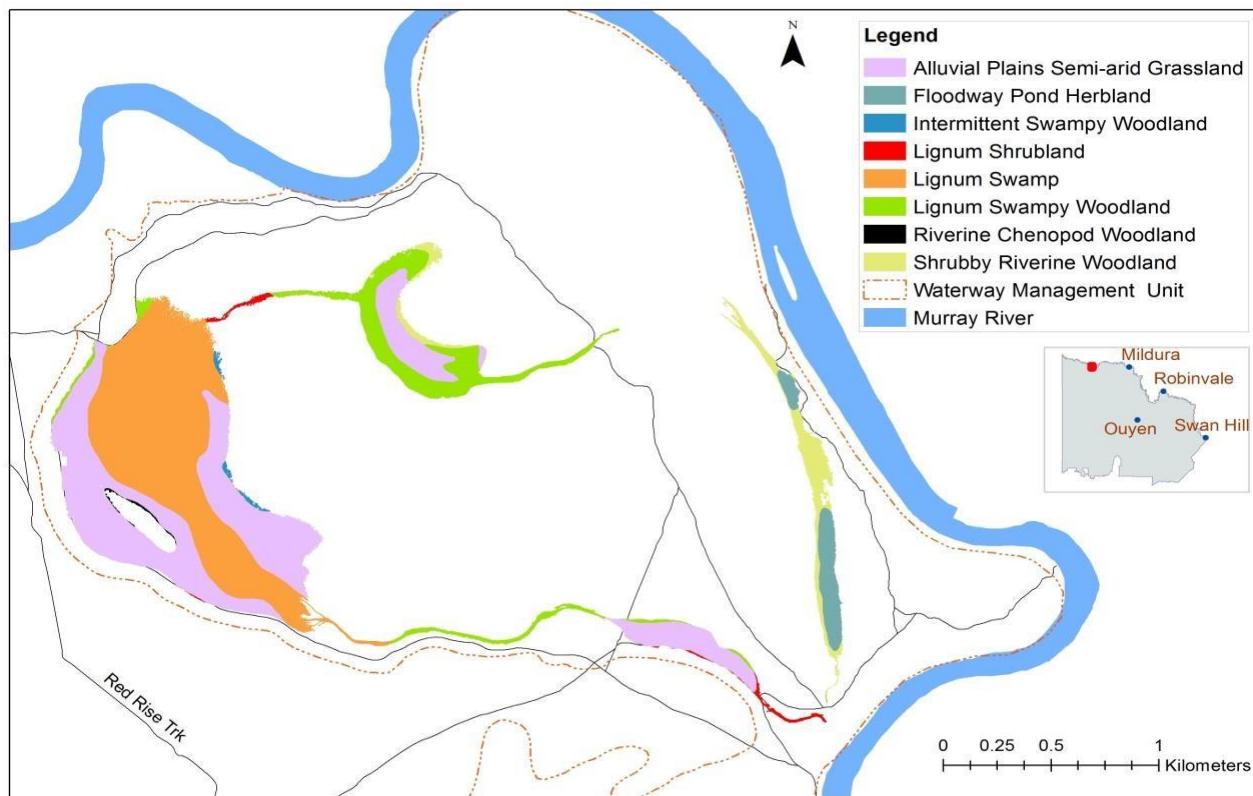
Figure 13a. Ecological Vegetation Classes (EVCs) in the target area at Neds Corner

Figure 13b. Ecological Vegetation Classes (EVCs) in the target area at Woolshed Creek

For a full list of EVCs within the Neds Corner area and details on each see Appendix 2. The EVCs in the target area at Neds Corner are illustrated in Figure 13.

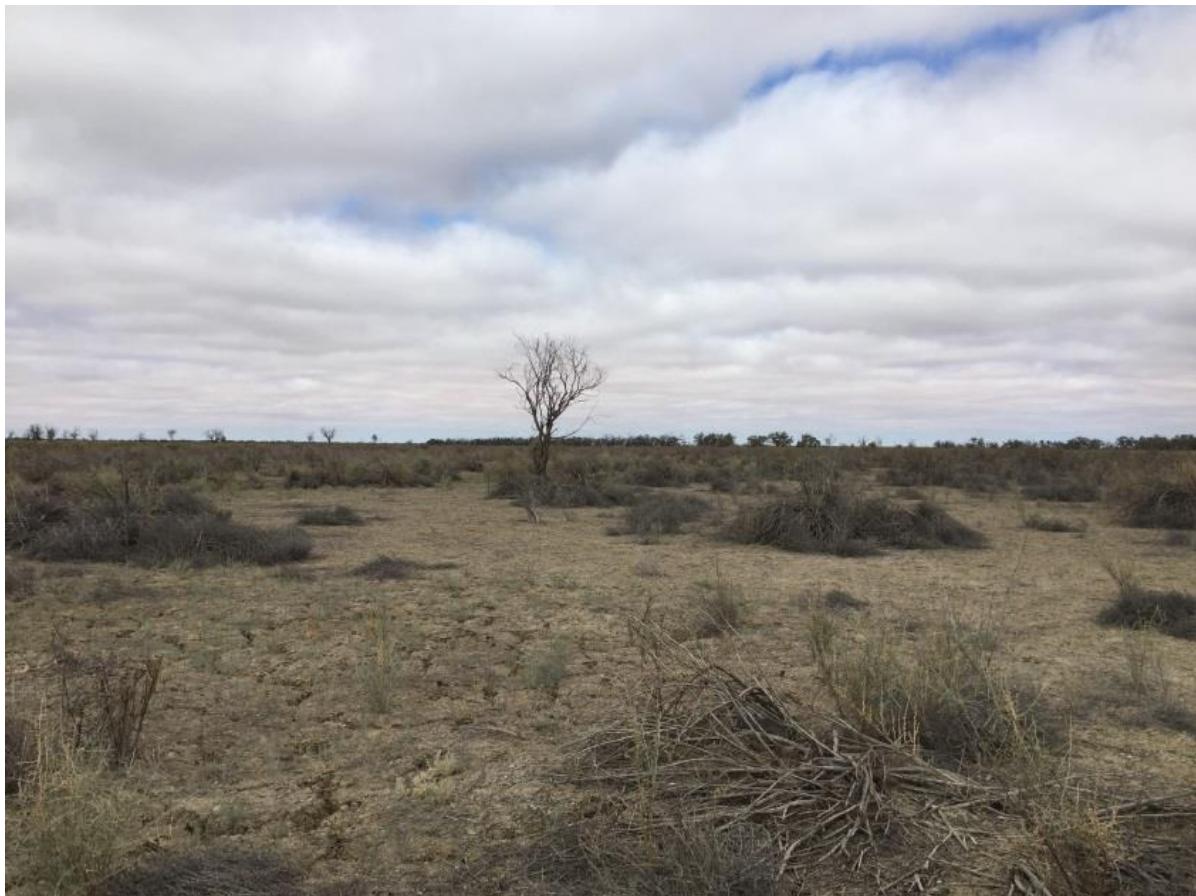
Figure 14. Lignum in the westernmost area of Lignum Swamp (Neds Central) appears to be responding well to environmental water delivery in 2015, with previous dieback exhibiting regrowth.

Lignum Swamp covers much of the inundation area of Neds Floodplain. This typically treeless EVC is widespread in low rainfall areas that are subject to infrequent inundation (DSE, 2005). This EVC is dominated by Tangled Lignum, (*Muehlenbeckia florulenta*), which becomes an extensive aquatic habitat for fish, reptiles and macroinvertebrates when inundated. It is also used as a nesting site by waterbirds, and as a feeding area by raptors, owls, and predatory reptiles (Ecological Associates, 2007a). The area mapped as Lignum Swamp in the target area is currently in poor health (Figure 14), although it is showing signs of recovery in response to the delivery of environmental water in 2015.

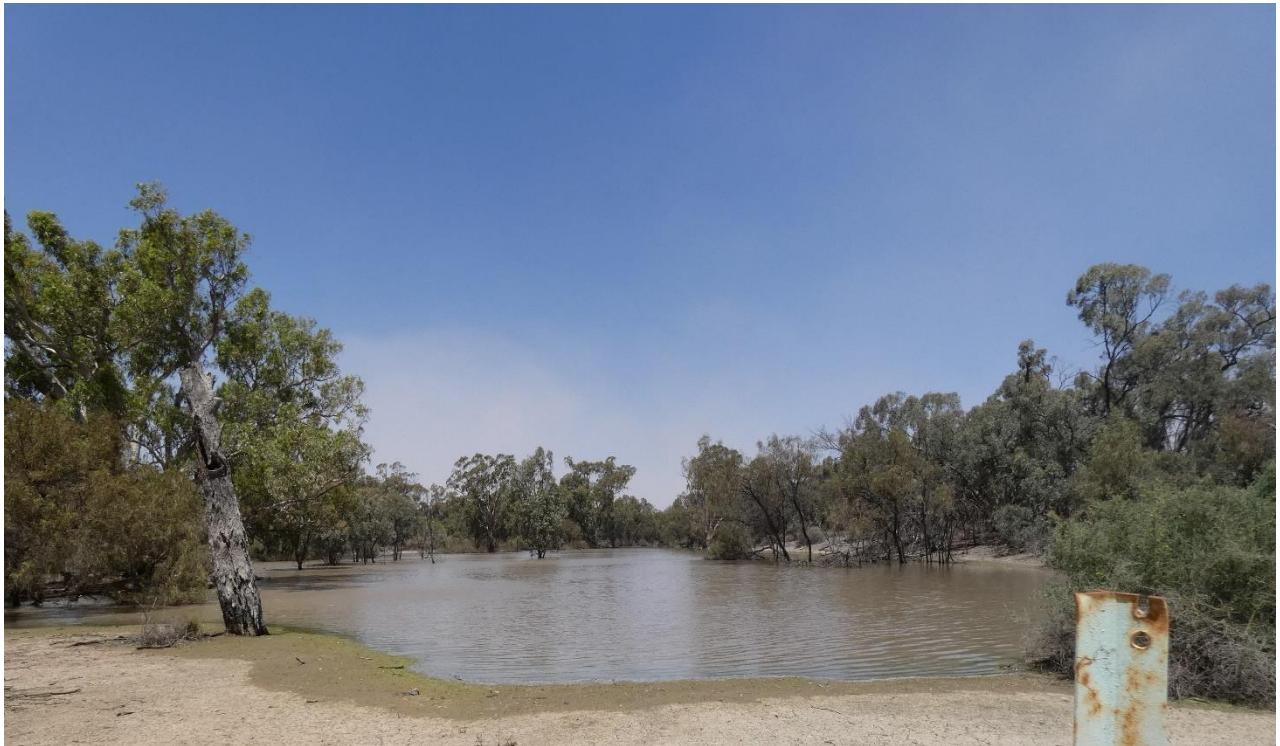
Figure 17. Tree canopies and herbland vegetation showing positive response to the 2019 watering event (photo captured 12 November 2019).

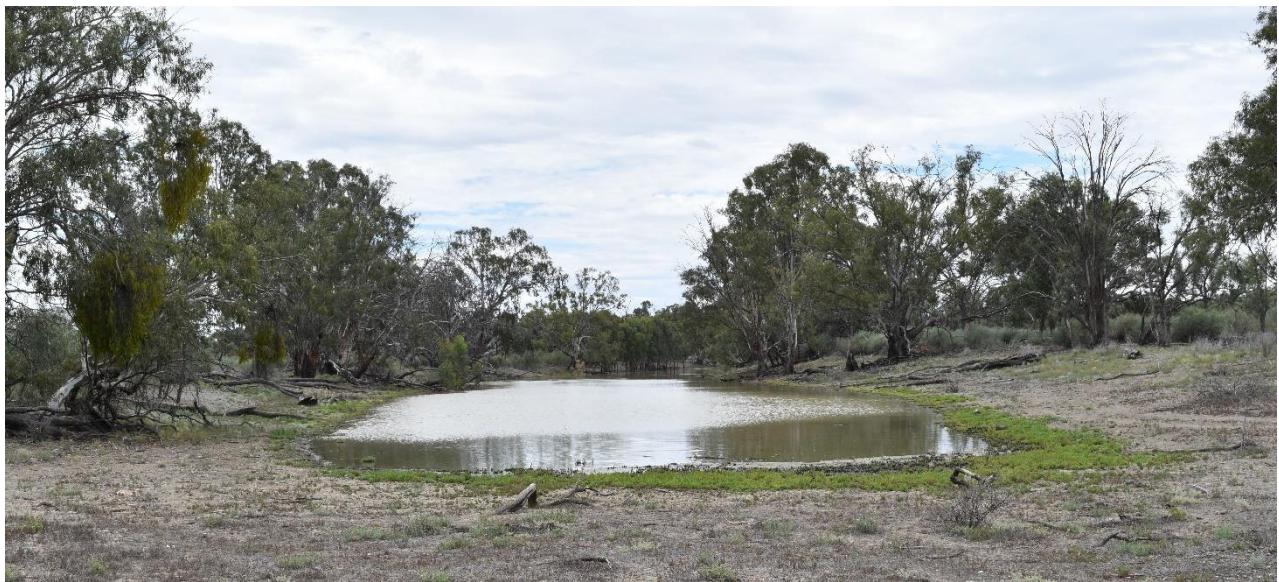
Figure 18. Woolshed Creek displaying a good response in water-dependent vegetation following the natural floods of 2016, photo taken Nov. 2017.

Woolshed Creek was initially viewed in November 2017 following the natural flooding in 2016. A positive vegetative response in both overstorey and understorey species was observed (Figure 18). The primary aim of the 2019 water delivery was to build on these outcomes.

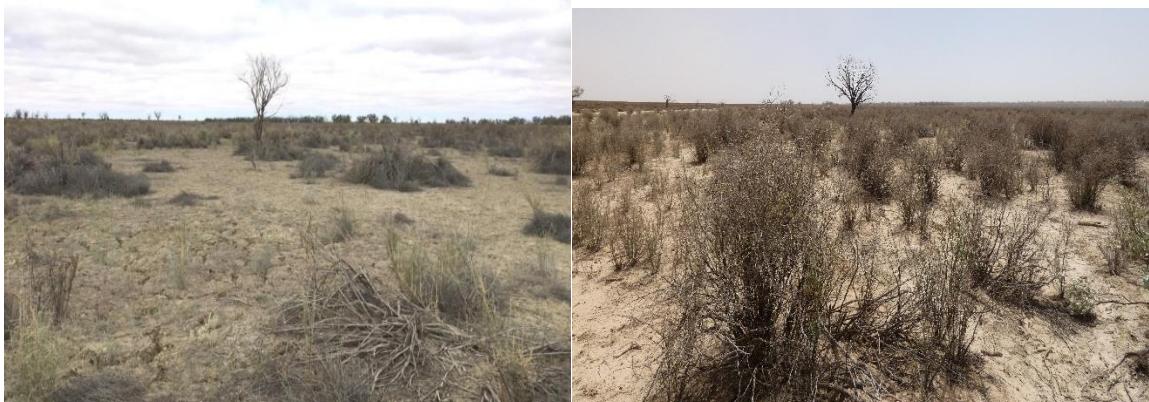
Figure 19a/b. Lignum at Neds Central had suffered severely when observed in 2016 (left), but was exhibiting a strong evidence of growth in response to several years of environmental water delivery and natural floods (right).

Lignum dieback was apparent across the floodplain of Neds Central, with loss of some overstorey in 2016 (Figure 19a). This vegetation has shown marked improvement after several years of environmental water delivery and natural floods (Figure 19b). Grey cracking soils were evident in this location and herbs and forbs were also noted. Areas situated high on the floodplain continue to exhibit signs of drought impact, with nearby Black Box overstorey in very poor health.

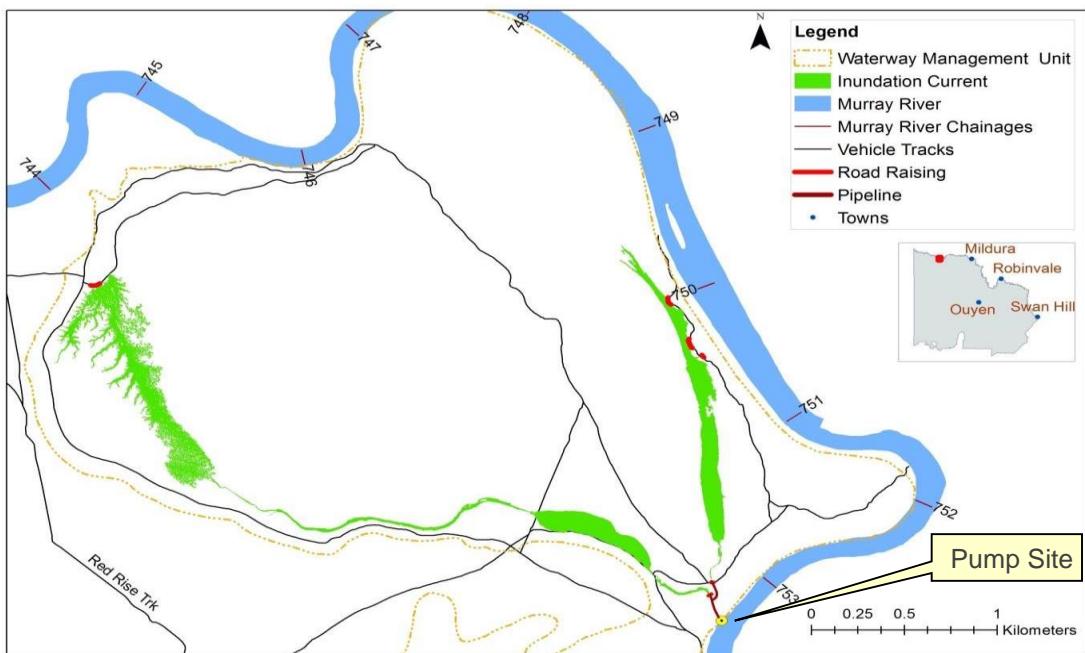
Figure 21a. Current inundation extents, Neds Central and East target areas

The optimal, minimum and maximum watering regimes for each stage are described in the following pages. The extent of the target area inundated is also presented in Figure 21a/b. Due to the inter-annual variability of these estimates, particularly the climatic conditions, determination of the predicted volume requirements in any given year will need to be undertaken by the environmental water manager when watering is planned.

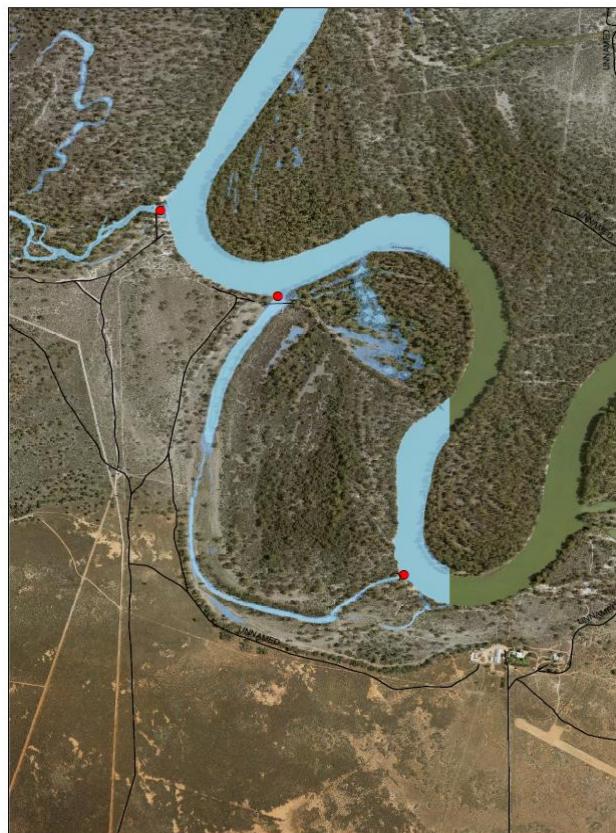
Figure 21b. Current inundation extent, Woolshed Creek target area

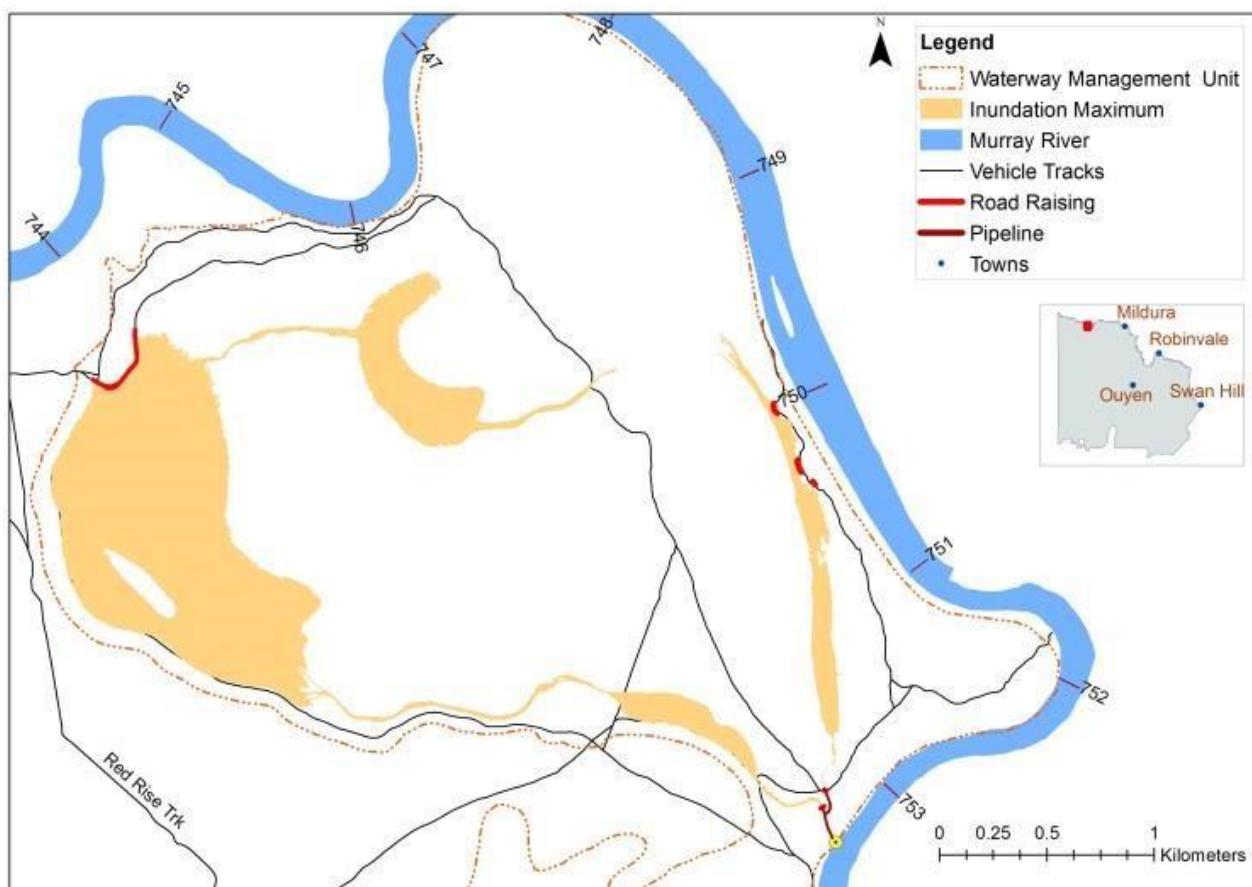
Figure 23. Maximum Inundation extent with additional track raising

Extending the length and height of the existing track raising works would expand the inundation extent to a total of 171 ha (Figure 23). This area could be inundated in accordance with the hydrological objectives stated in Table 12, page 39, to promote diversity and limit the invasion of terrestrial species within the Alluvial Plains Semi-arid Grassland EVC.
