Burra Environmental Water Management Plan

Sunraysia Environmental (2015) *Burra Environmental Water Management Plan*, Report for the Mallee Catchment Management Authority, Mildura, Victoria.

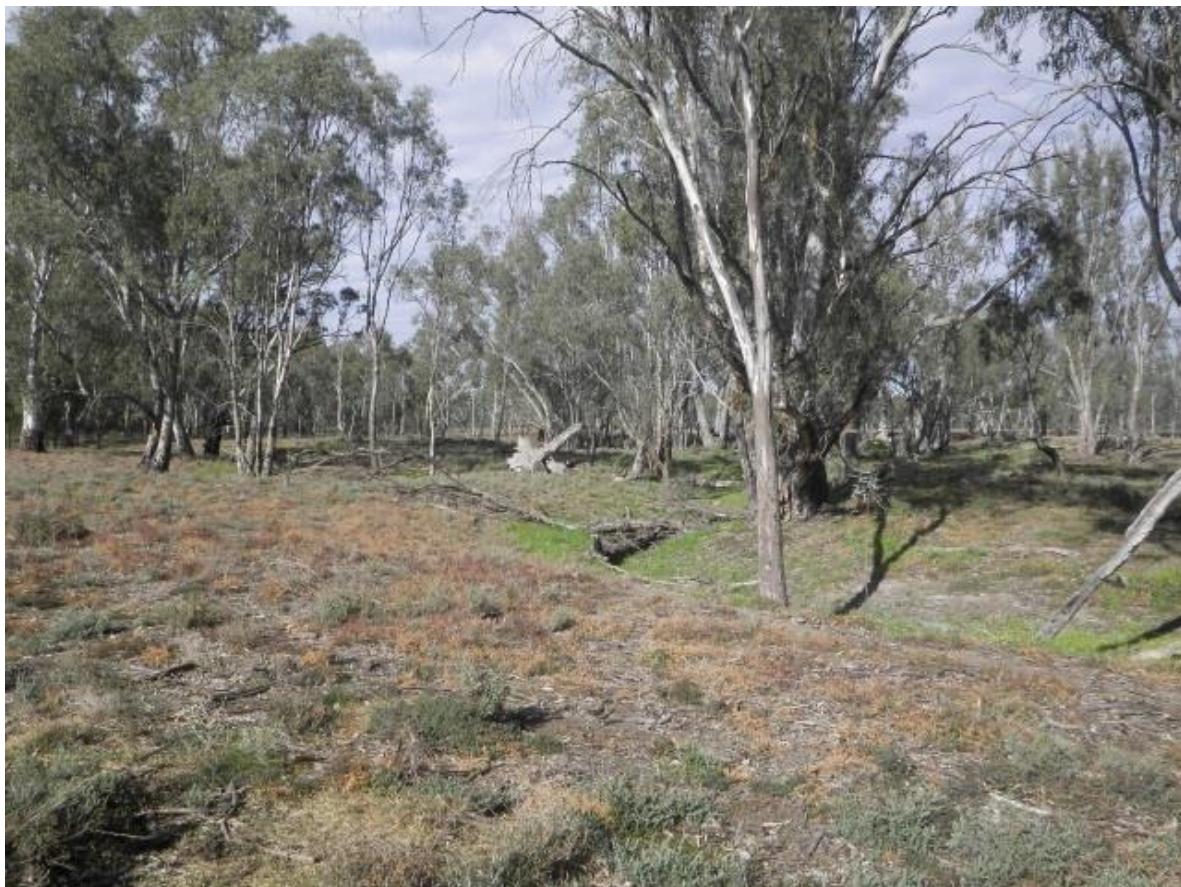
Figure 5 - Burra Creek through Burra Creek South Proper

Burra Creek South Proper is a shallow and wide creek bed (Figure 5) approximately 3 km in length. Burra Creek South Proper is dominated by Lignum Swamp and Lignum Swampy Woodland vegetation communities. Tangled Lignum, provides valuable habitat for waterbirds, fish and macro-invertebrates, and can be an important feeding area for raptors, owls and predatory reptiles (Ecological Associates, 2007).

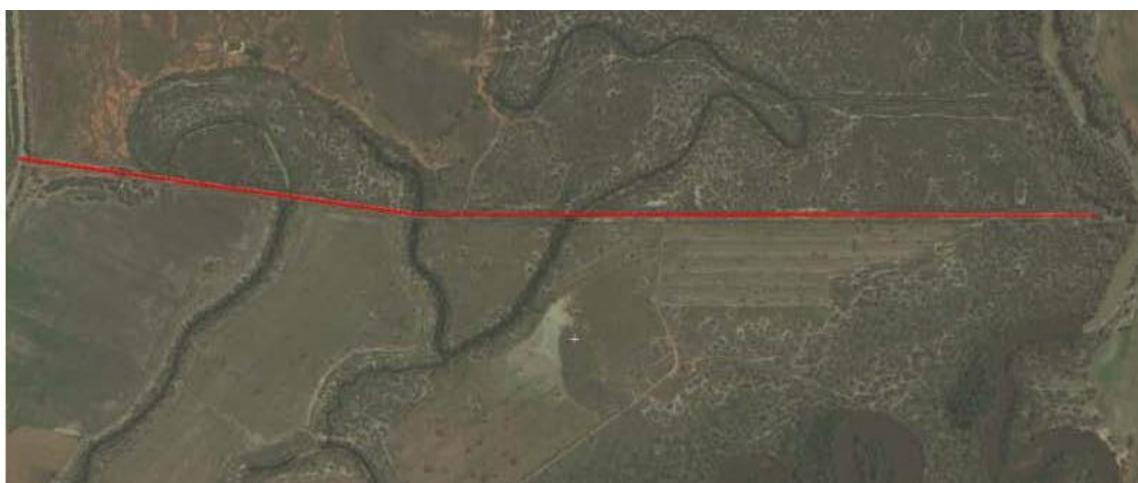
Figure 6 - Irrigation channel crossing Burra Creek

Burra Creek South is connected to the Murray River at the southern end of Burra Creek South (~1319), Connection point C and at another site around river km 1307.5, Connection Point B (Figure 3). Burra Creek South and Burra Creek North are physically separated by a large irrigation channel (Figure 6 and Figure 7).

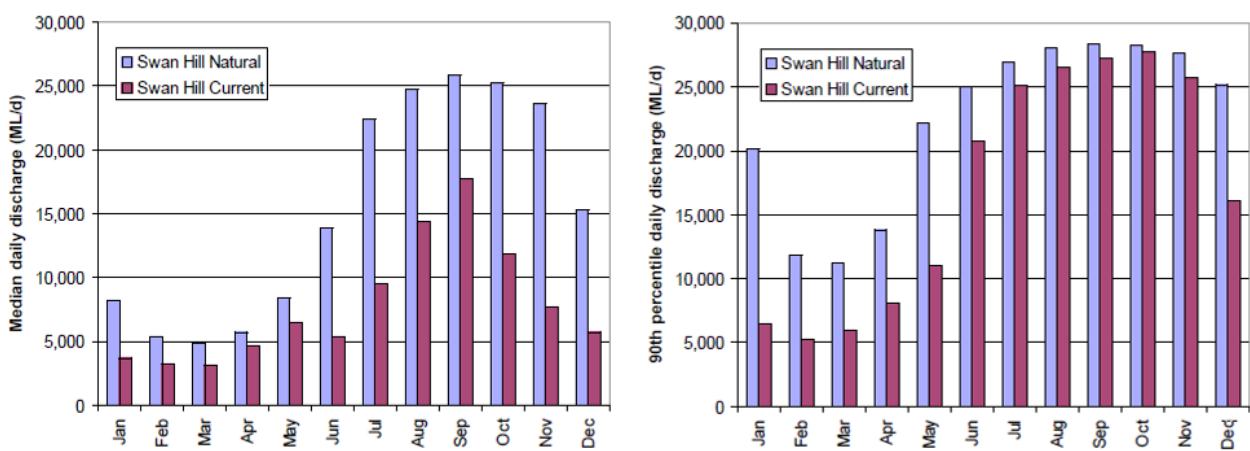
Figure 11 - Distribution of median flows and 90th percentile flows for each month in the Murray River through Burra section for natural and current (benchmark) conditions. Source: derived from MDBC MSM-Bigmod 109-year data (Ecological Associates 2006).

The seasonal distribution of flows in this section of the Murray River shows that, despite a reduction in discharge, the river retains the same annual pattern of higher flows in winter and spring with lower flows in summer and autumn (Figure 11).

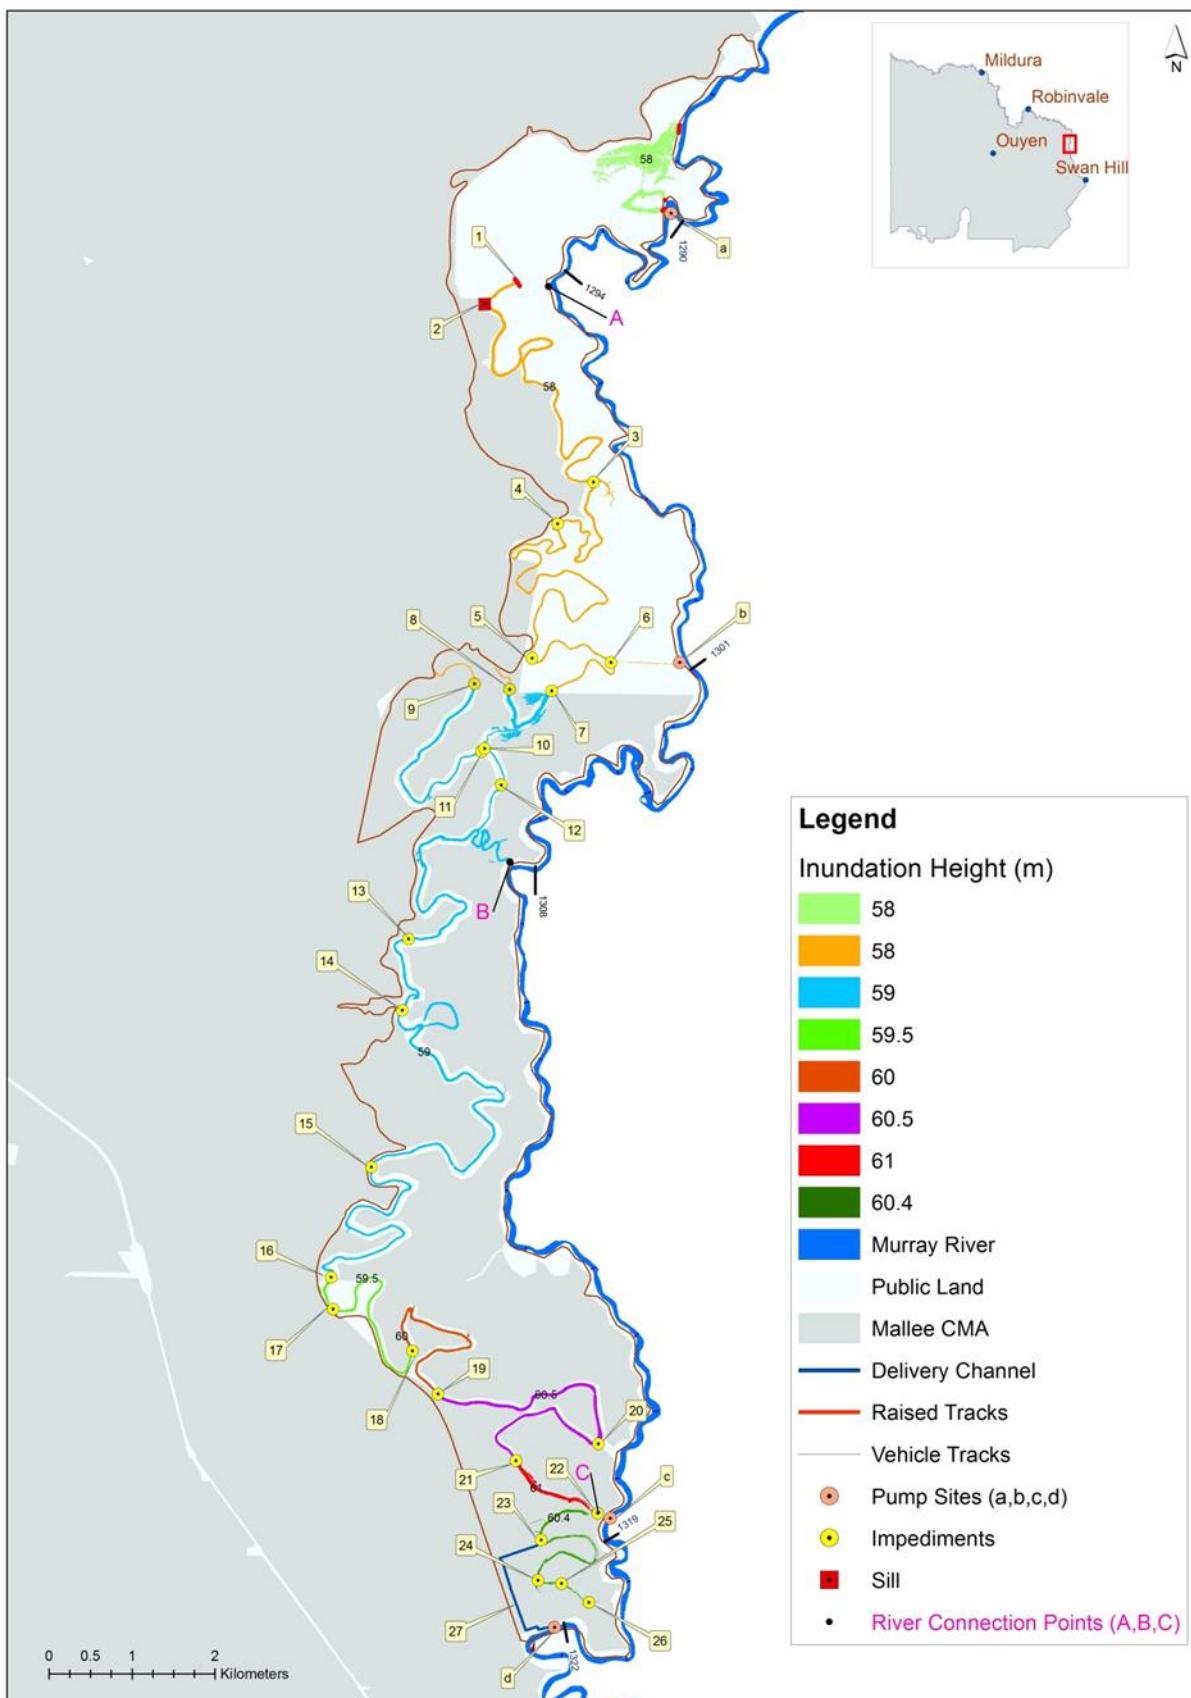
Figure 12 - Burra Creek river connection points and inundation heights, and impediments to flow at Burra.

The mid-section of the creek receives floodwaters from Connection Point B (Burra Creek South) (Figure 12) via a meandering natural channel connection. Water flows from this location in both directions within the creek.

The lowest point, Connection Point A (Burra Creek North) (Figure 12) receives water first from a natural inundation as water backs up in Burra Creek towards the first impediment.

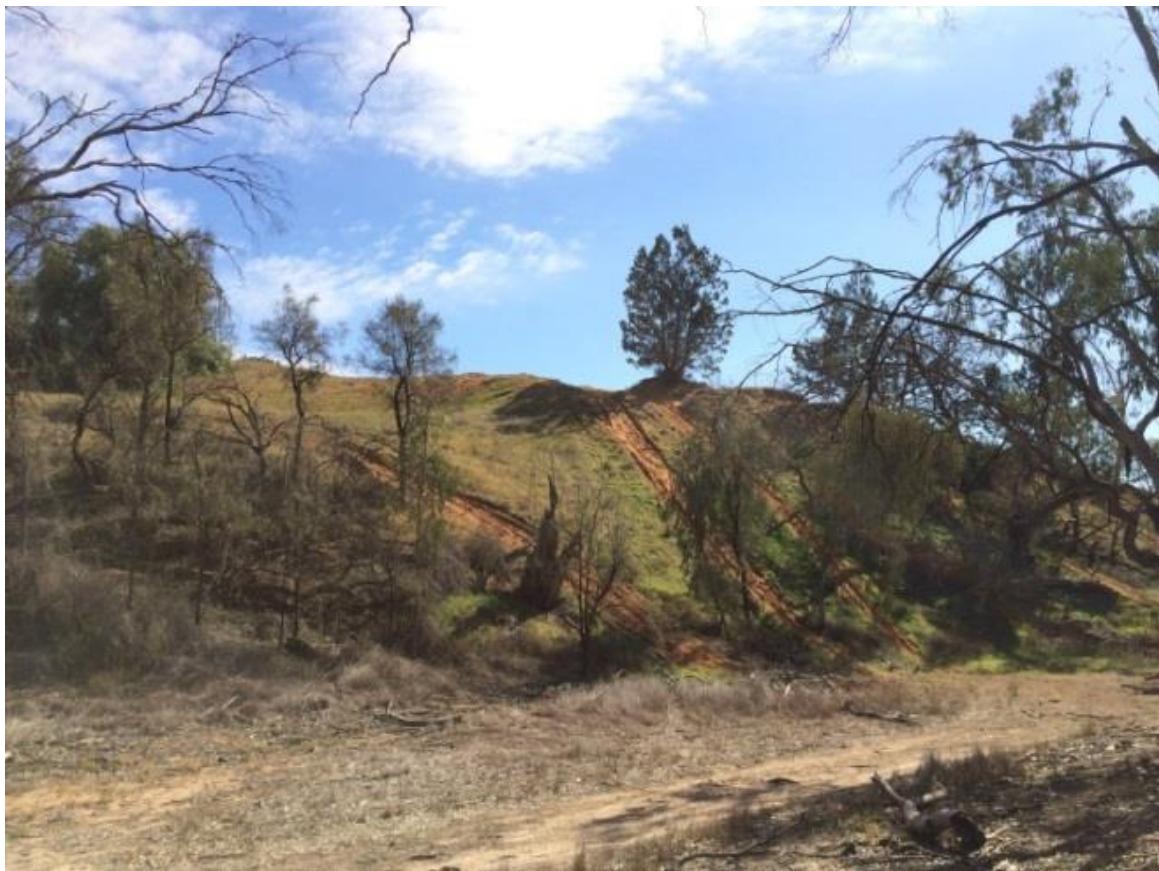
Figure 15 - An area of semi-arid woodland on a sand dune adjacent to the creek (Deadmans Hill). The creek bed is shown in the foreground. Erosion and loss of native vegetation on Deadmans Hill from motorbike activity is notable.

- Semi-arid Chenopod Woodland occurs alongside Burra Creek, near Impediment Site 5. At this location, the eastern bank of the creek is formed by a sand dune, which is likely to be of very high Aboriginal Cultural Heritage significance. It is subject to disturbance by recreational motorbikes (Figure 15), with several tracks crossing both the dune and the creek bed.
- Semi-arid Woodland occurs adjacent to Burra Creek at Impediment Site 1 (where road raising has been conducted to retain water within the creek).

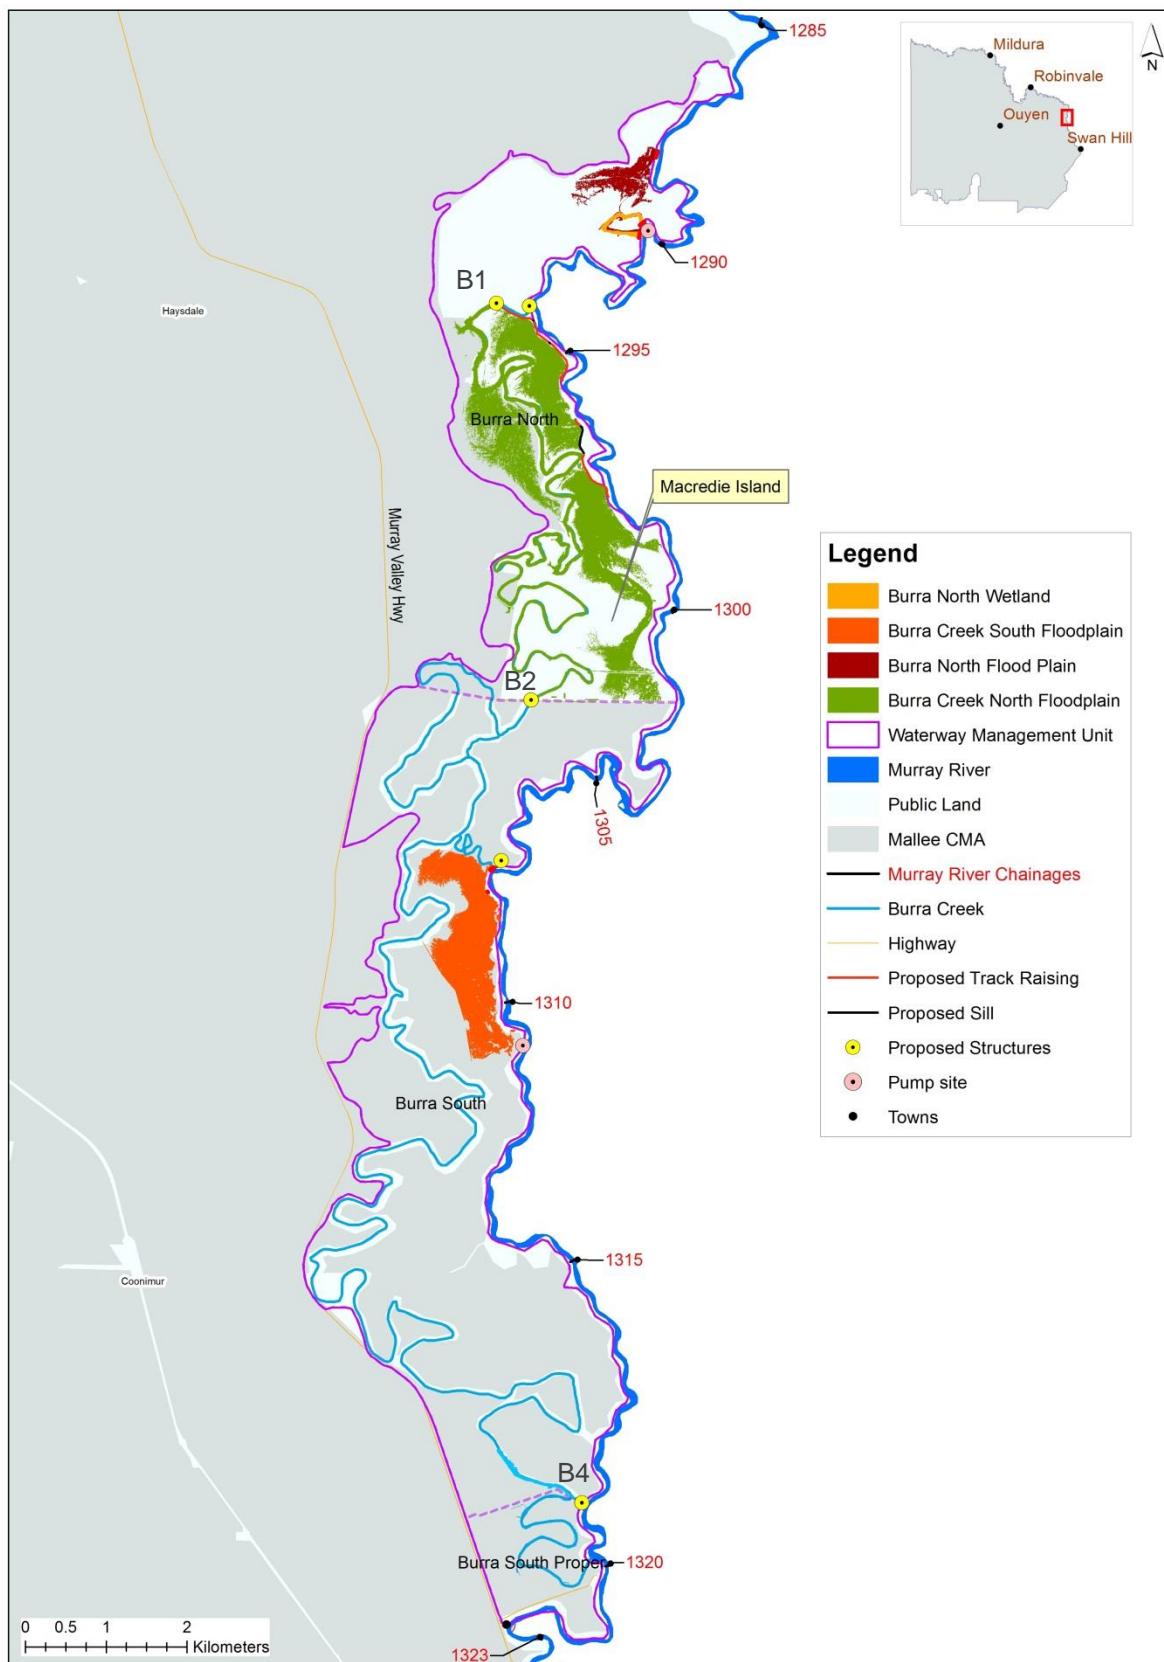
Figure 19 - Inundation extents achievable with proposed infrastructure.

Burra Areas	Current extent (ha)	Proposed Infrastructure inundation extent (ha)	Combined total (ha)
Burra North Wetland		7	
Burra North Floodplain		24	32
Burra North	50	357	407
Burra South	109	91	200
Burra South Proper	8		8
Total (ha)	167		647

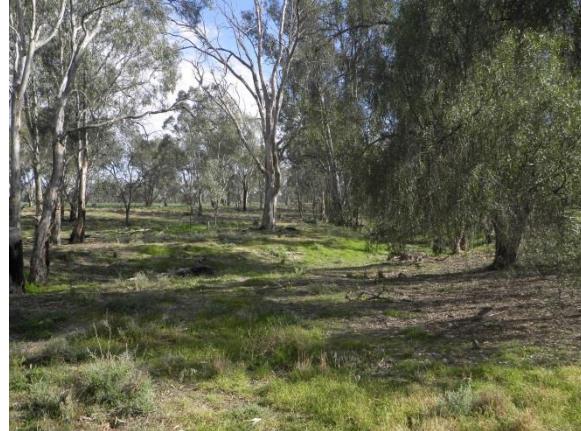
Burra Creek South Proper, the creek bed in the middle distance. This view looking northwest.

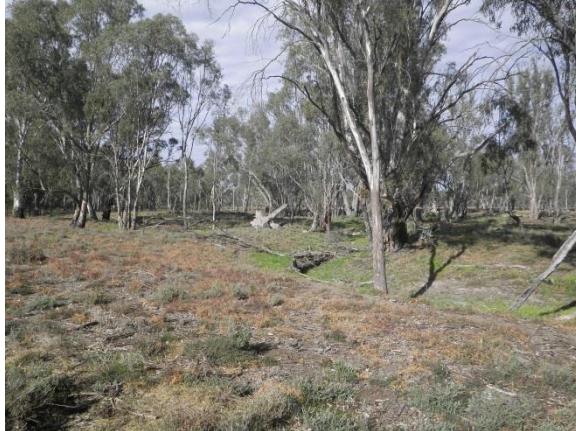
Burra Creek South Proper, looking south.

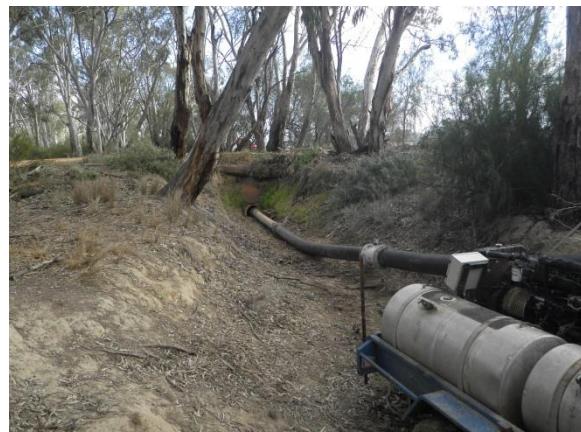
Pump Site C, showing temporary pump in foreground and pipe through Impediment 22. This is also River Connection Point C, looking away from river.

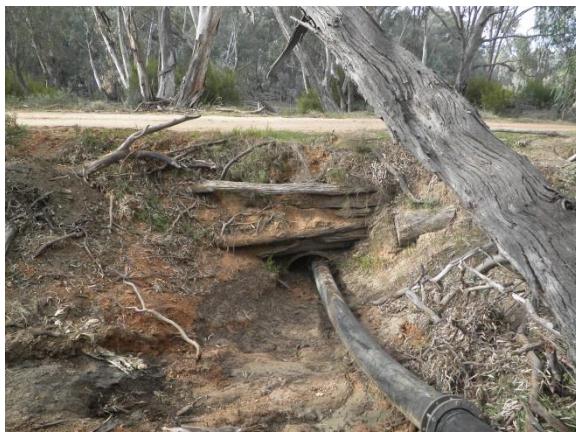
The downstream side of Impediment 22, looking back towards river, (visible in the background).

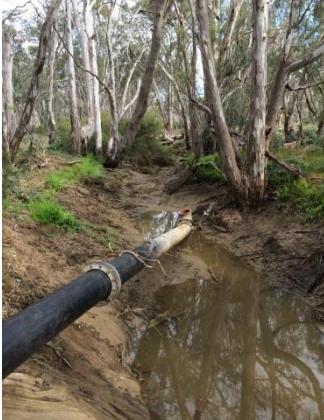
<p>The outlet to the pump at Pump Site C, (downstream of Impediment 22) showing recession of water; pumping can soon recommence.</p>

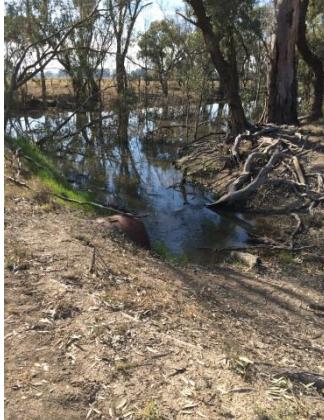
<p>Impediment 19 (left of image) is an access track used by a private landholder. Pipe culvert and altered creek course is shown in the foreground.</p>

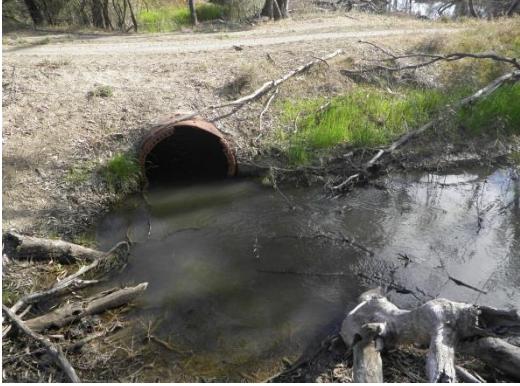
<p>The culvert at Impediment 19, looking downstream.</p>

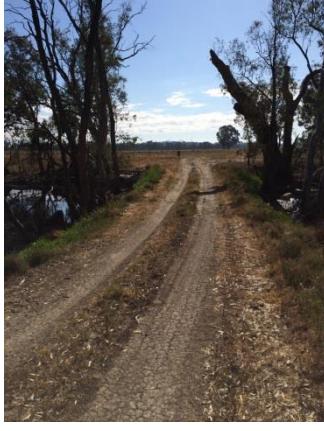
<p>The private access track that forms Impediment 19).</p>

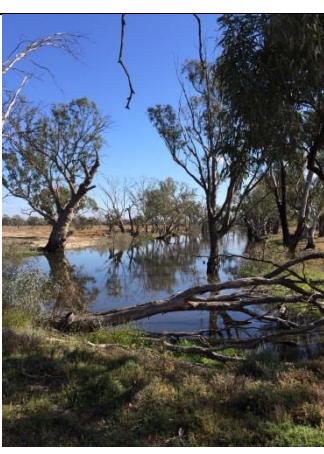
<p>Impediment 18. Fallen timber often accumulates at the upstream entrance to culverts. In this image, on the left bank of the creek, intensive disturbance is evident from agricultural uses.</p>

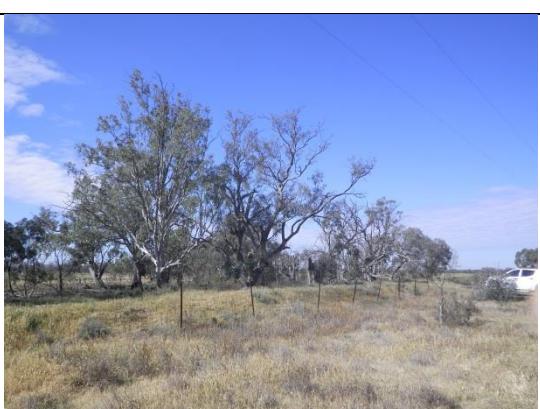
<p>A levee has been constructed in places along the creek line, presumably to prevent inundation of private land, but also reducing rainfall runoff to the creek. Tree canopy health is noticeably poor, but regenerating.</p>

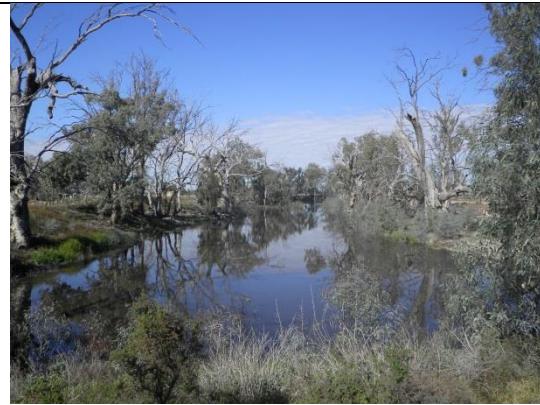
This image captured from an access track that crosses the creek at Impediment 18, vegetation growing on the edges of this track can be seen in the foreground.

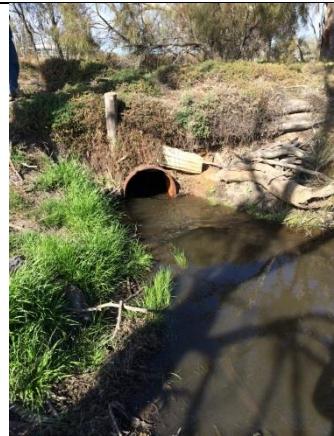
The culvert at Impediment 18, again diverting the creek flow to just outside the natural bank. Fast-flowing water can be seen entering the pipe, and evidence of logs removed from the entrance on right of picture.

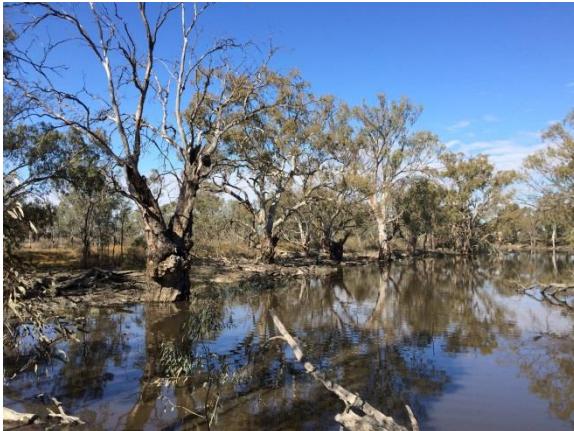
Upstream of Impediment 16.

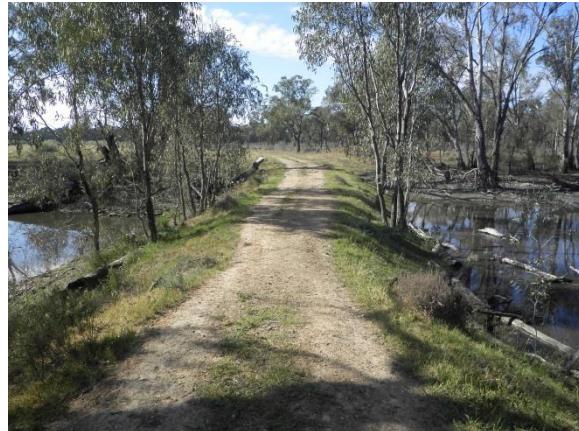
The private access track at Impediment 16. Note the difference in water levels from upstream (right) to downstream via the culvert (left).

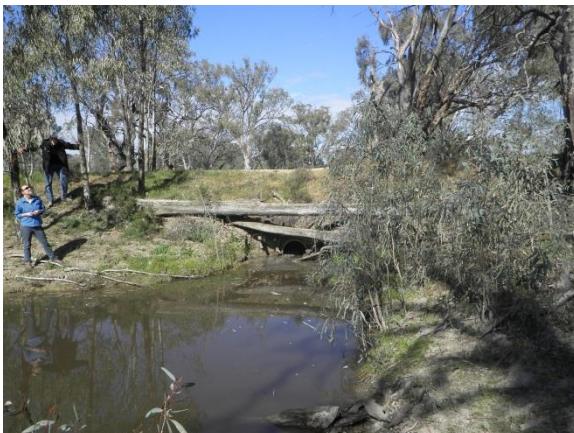
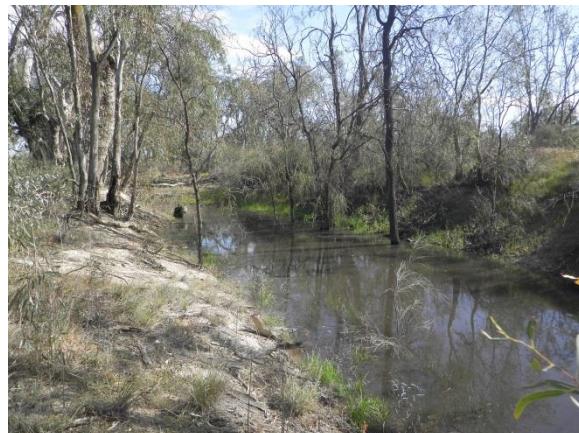
<p>Downstream of Impediment 16.</p>	<p>A narrow cutting has been excavated around Impediment 17. The impediment at this location is no longer serves any obvious purpose.</p>

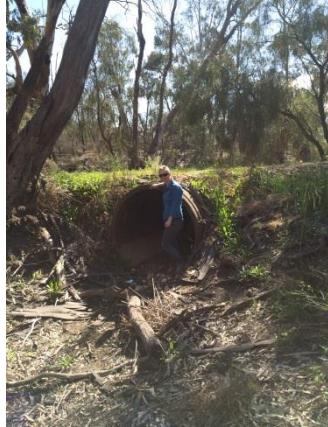
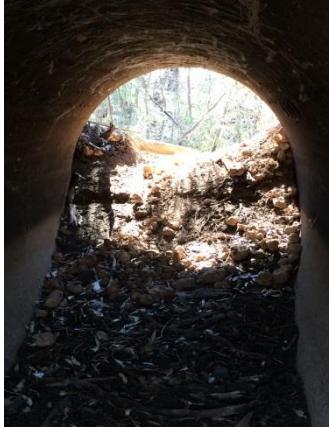
<p>At Impediment 7, the road parallel to the channel and pipeline crosses the creek, with a large culvert enabling passage of creek water.</p>	<p>The downstream end of the culvert at Impediment 7, however, is partially blocked by soil and rubble.</p>

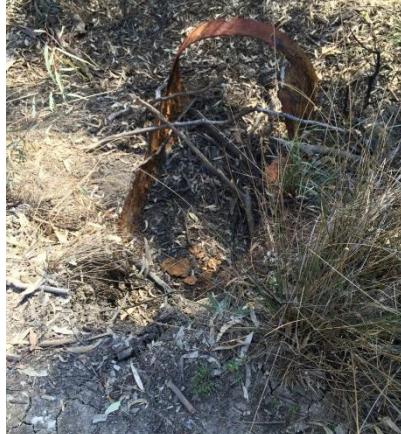
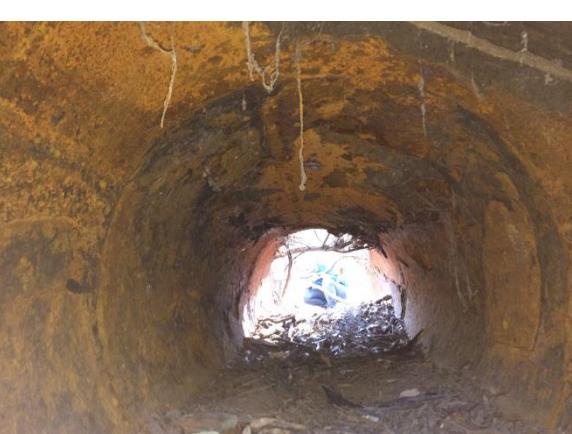
<p>The aged pipe culvert at Impediment 6 is in worrying need of attention.</p>	<p>An internal view of the pipe culvert at Impediment 6.</p>

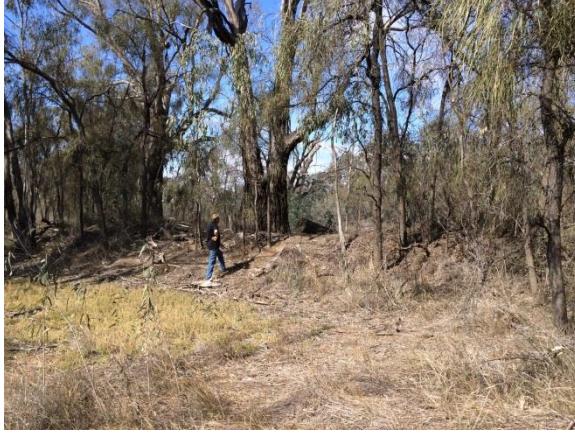
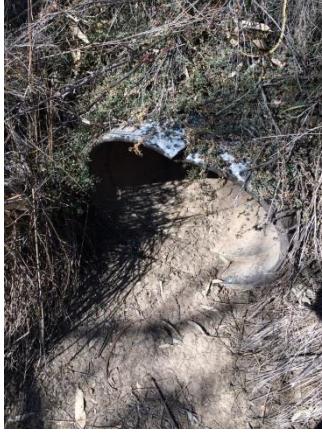
<p>Impediment 5 is a long levee completely crossing the creek bed. A narrow cutting and culvert has been constructed to the east of this levee.</p>	<p>The ~600 mm diameter pipe culvert at the cutting at Impediment 5. This view is the downstream end.</p>

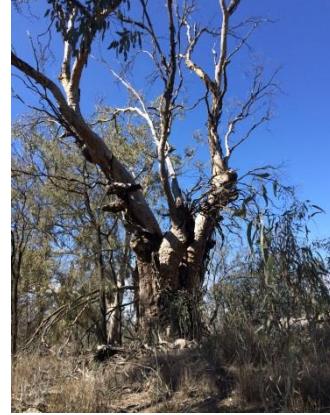
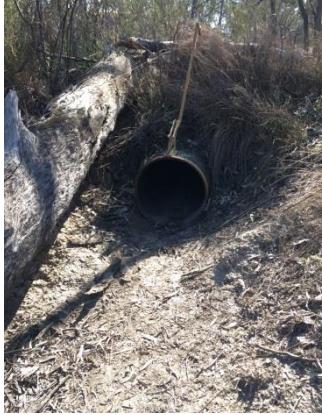
<p>Impediment 5. Several large old River Red Gums have suffered dramatically in the past, however regeneration of saplings has occurred in recent years.</p>	<p>The upstream end of the pipe culvert at the cutting at Impediment 5. Evidence exists of past ability to close off the culvert.</p>

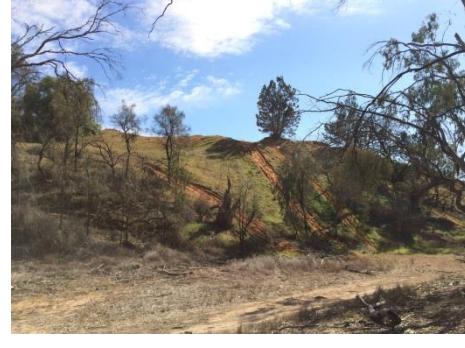
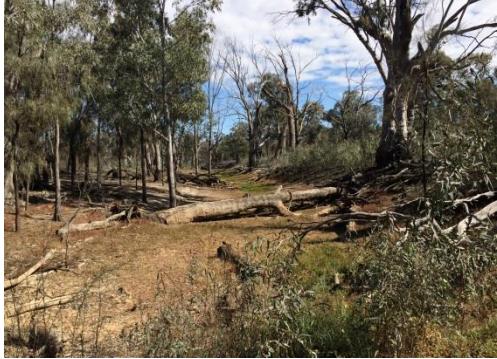
<p>The sand dune immediately downstream of Impediment 5. Note significant disturbance by motorbike access.</p>	<p>Upstream of Impediment 1, showing dead trees and healthy regeneration.</p>

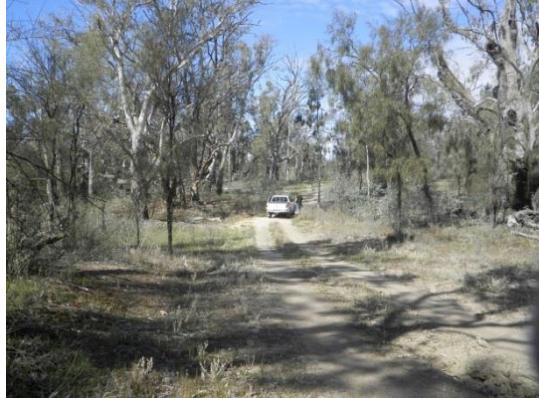
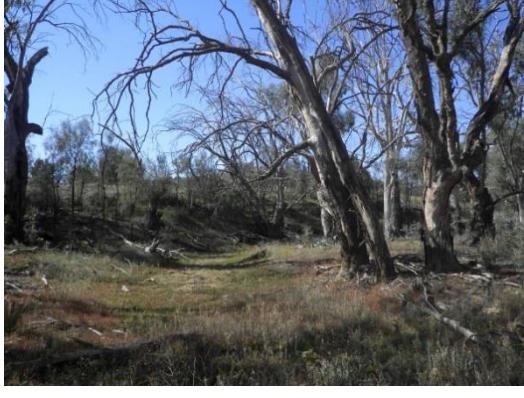
<p>The low bank constructed at Impediment 1 traverses the creek bed and enables water to be held in the creek rather than returning to the Murray River.</p>	<p>Downstream of Impediment 1, with sand dune in background, and several dead River Red Gums in middle distance.</p>

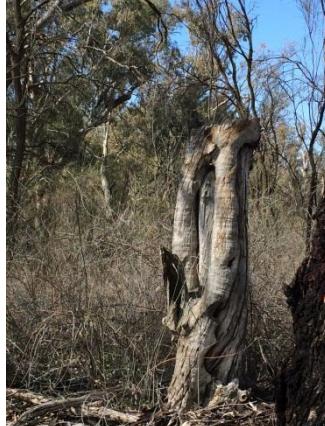
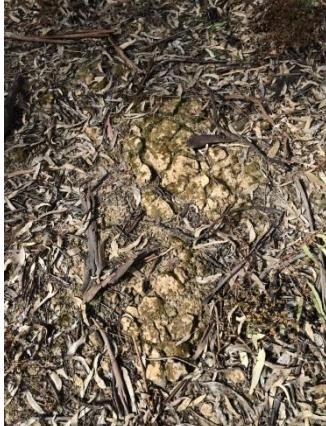
<p>A scarred tree on the floodplain near Impediment 1 that may be of cultural significance.</p>	<p>A suspected hearth located on the floodplain near Impediment 1.</p>

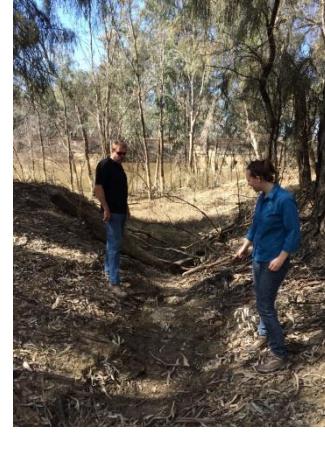
<p>The downstream Connection Point A for Burra Creek and the Murray River (shown in background).</p>
